ANDREWS PROPERTY INSPECTIONS LLC

COMMERCIAL PROPERTY INSPECTION

1234 Main St. Mays Landing NJ 08330

02/02/2022 9:00AM

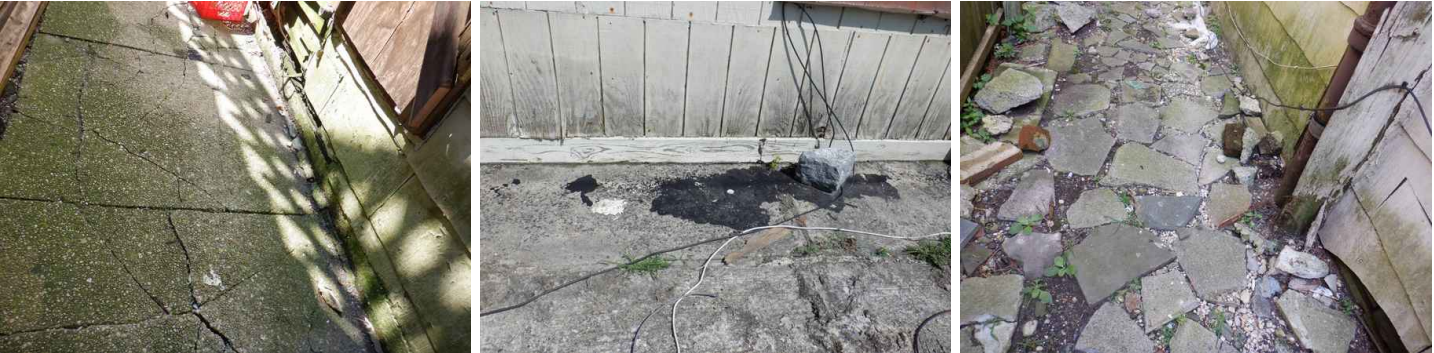
2.2.1 Walkways, Patios & Driveways

WALKWAY CRACKS - MAJOR

Major cracks or settlement observed. Recommend concrete contractor evaluate and correct to prevent trip hazard & preserve appearance.

Contact a qualified concrete contractor.

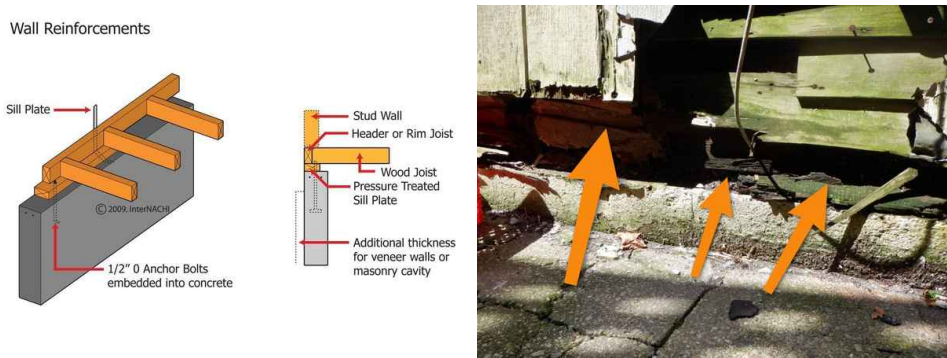
3.3.1 Beams, Columns, & Joists

SILL DAMAGE

Most of the sill plate that we could see was rotted or not even there anymore. Any portions of the rim joist or sill that show damage should be repaired or replaced as needed. In many cases the cause is exterior moisture intrusion.

Recommendation
Contact a qualified general contractor.

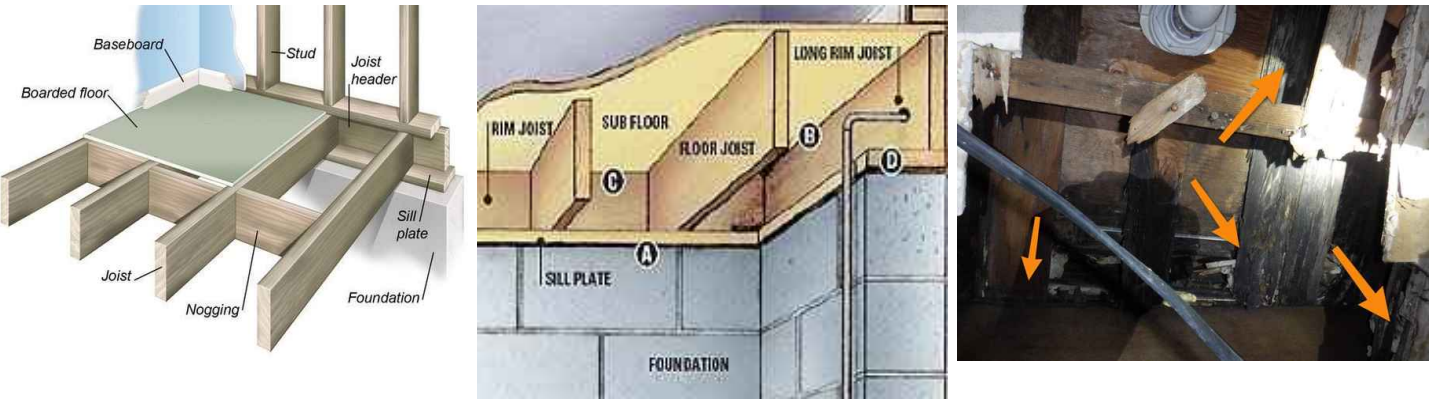
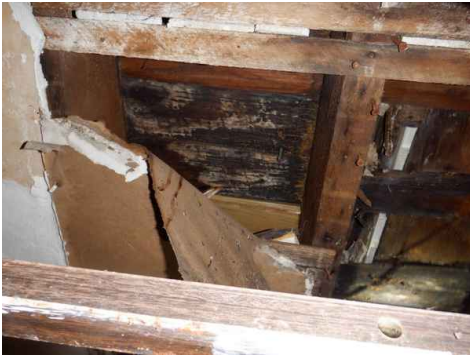
3.3.2 Beams, Columns, & Joists

JOIST DAMAGE

Rotted joists and structural members were observed throughout the building. This is a safety issue as the floor could break under a person's weight.

Structural damage was observed in the underlying floor structure joists. Recommend a qualified contractor evaluate and repair soon.

Recommendation
Contact a qualified carpenter.

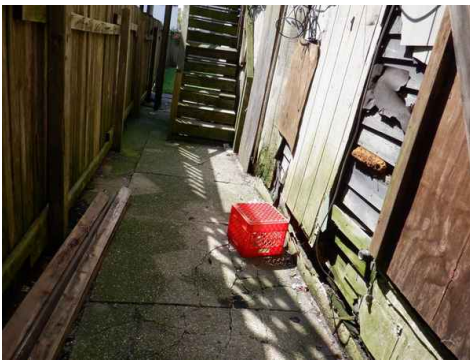
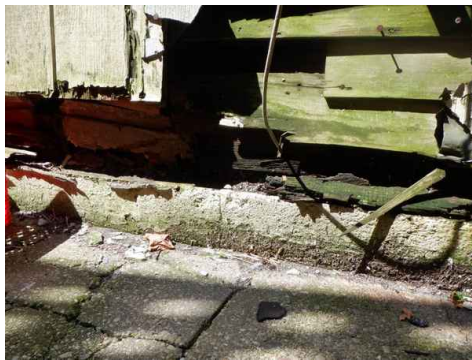
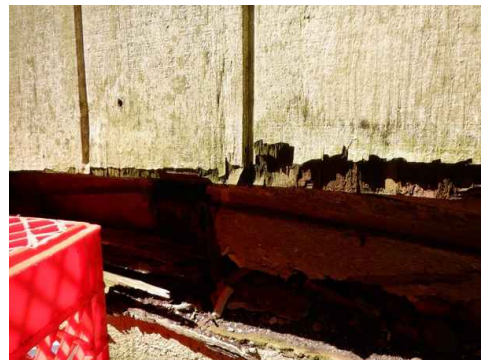
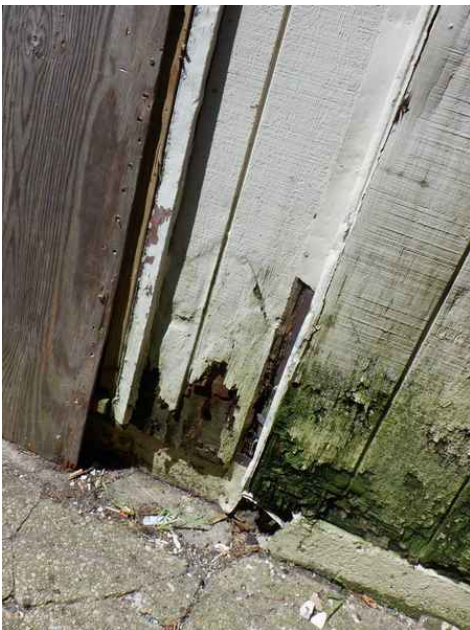
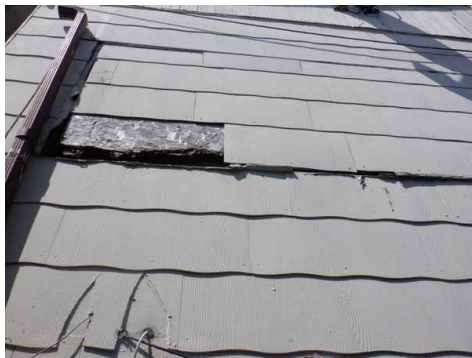
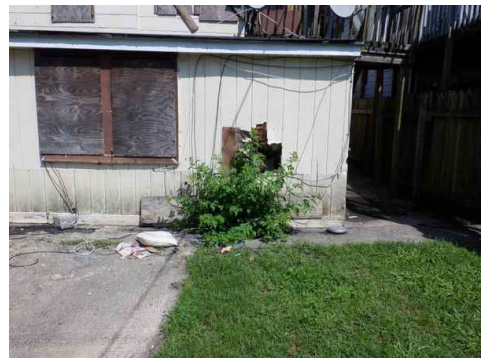
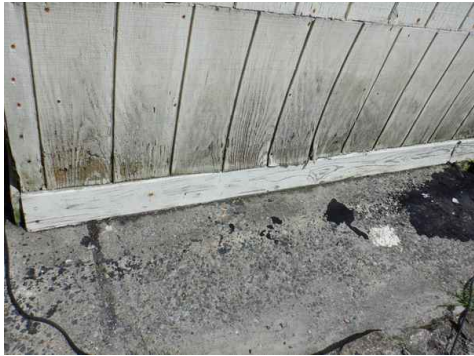
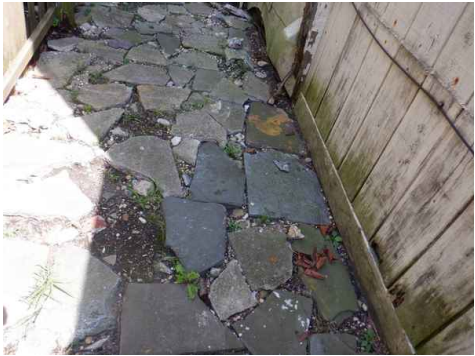
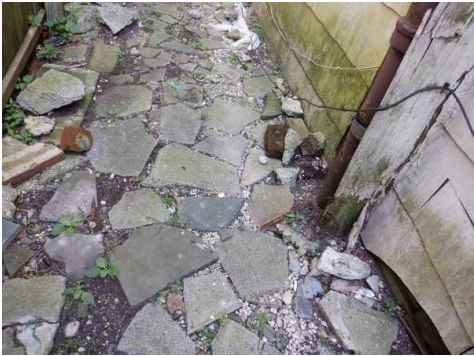
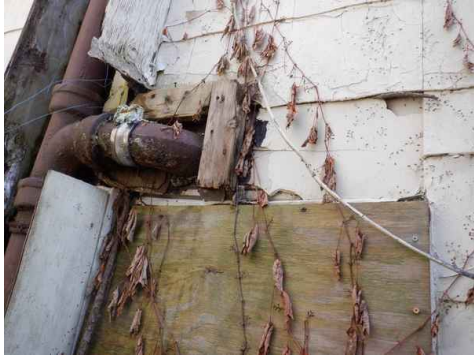
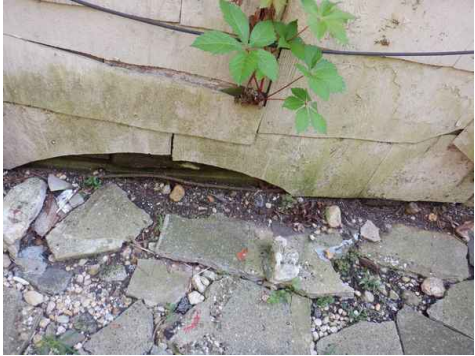
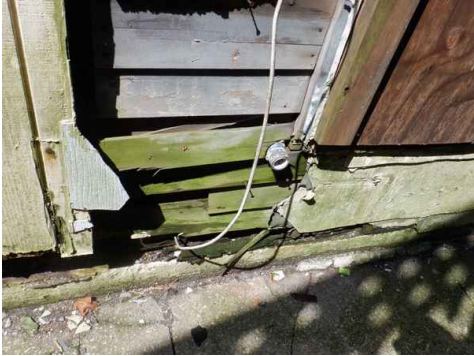
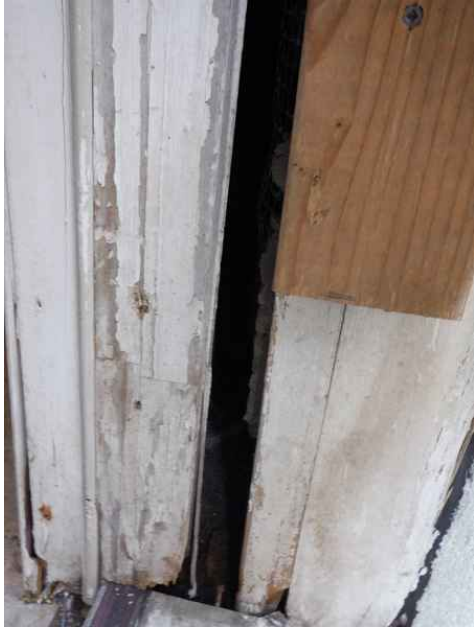
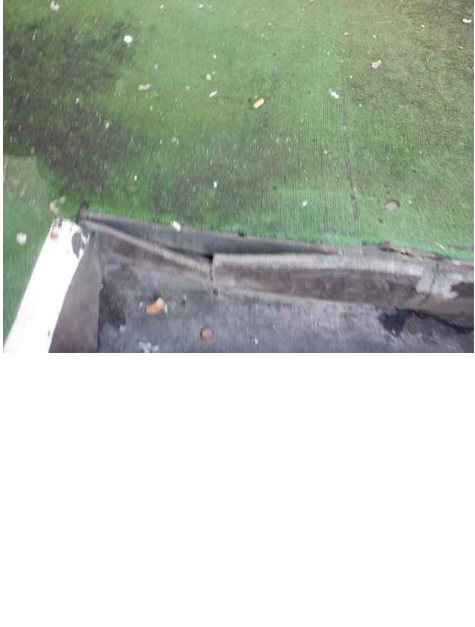
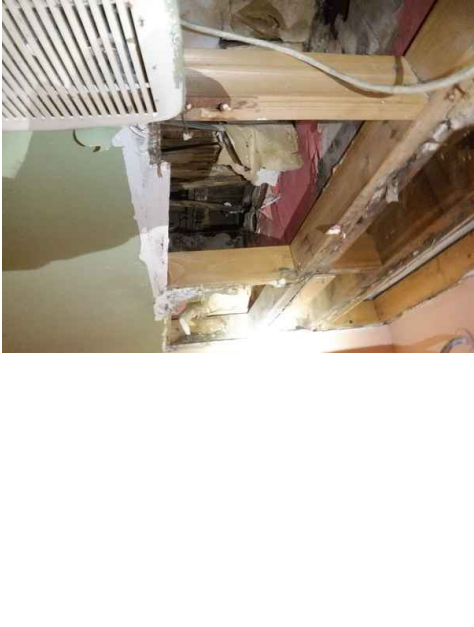
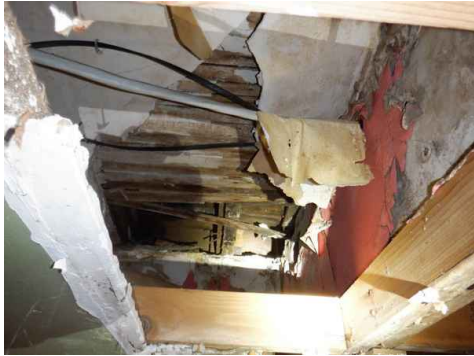
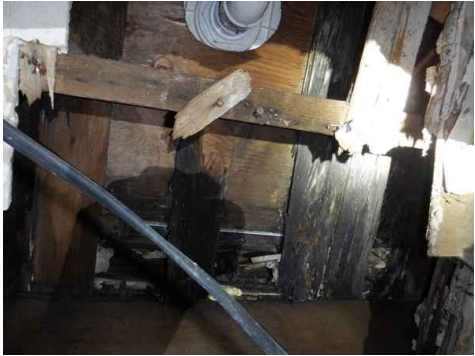
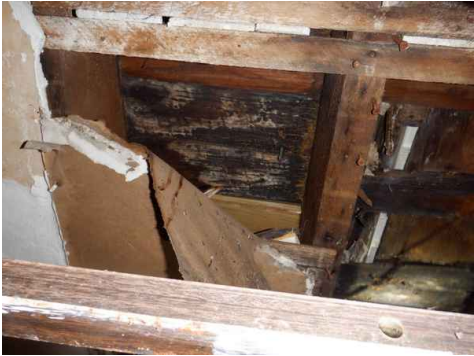
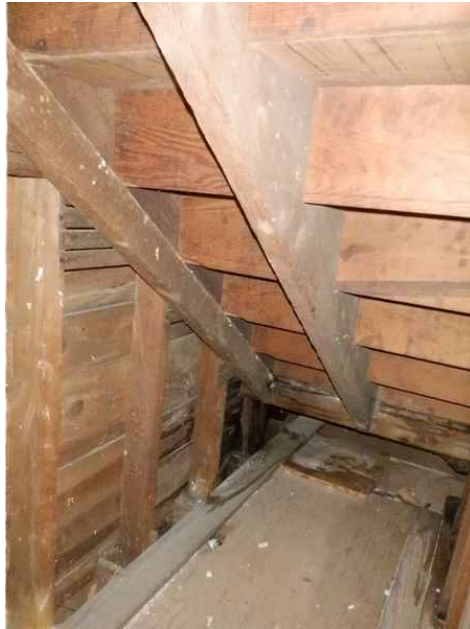
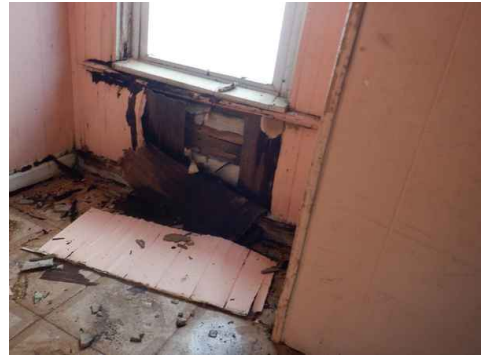
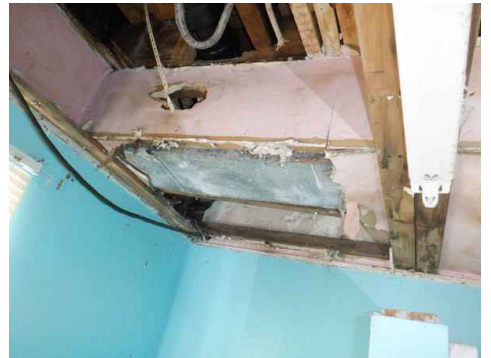
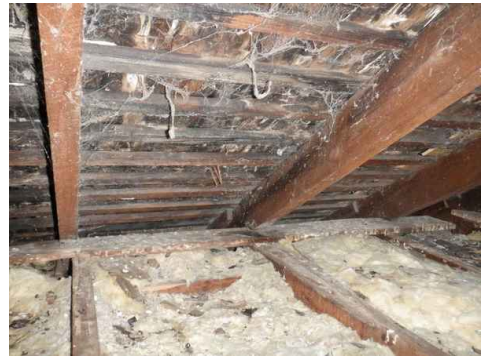
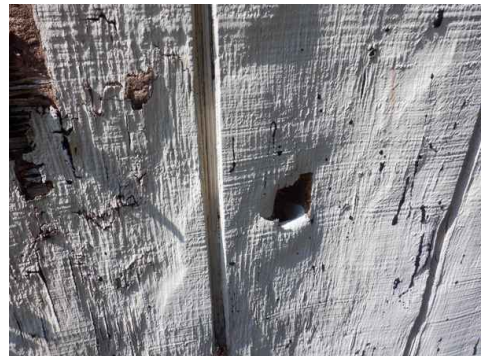
3.3.3 Beams, Columns, & Joists

ROTTED WOOD

Numerous locations having water-damaged materials were noted. Recommend repair or replacement of these components soon. Repairs can be costly. Some of these areas are in passageways where the floors could break under the weight of a person.

Contact a qualified carpenter.

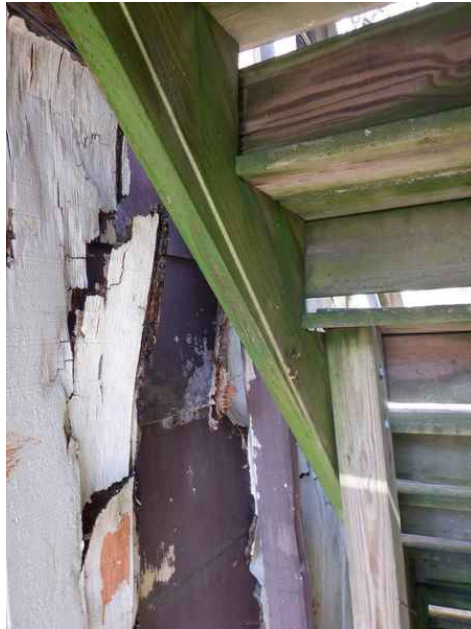
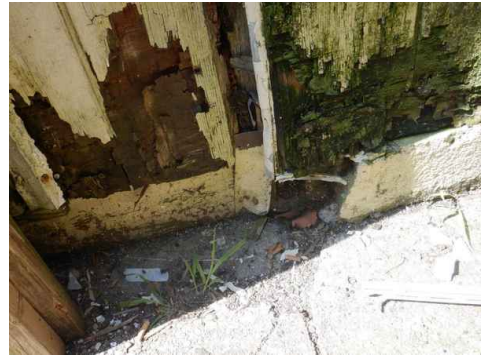
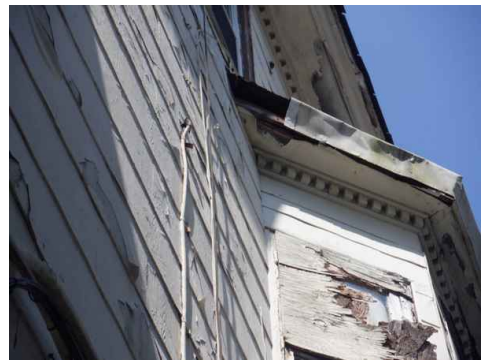
I pushed my thumb through the siding at the rear east corner, all the T-111 is like a sponge and very soft.

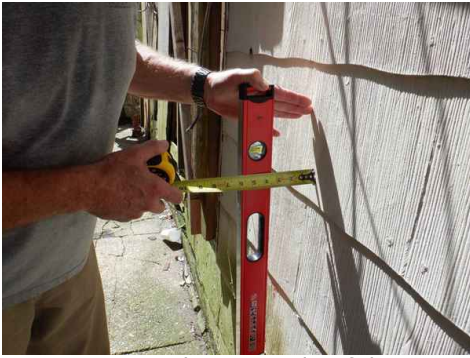
The structural settlement was noted in one or more areas. The center of the building has sunk at least 4 inches in 4 feet in some areas and the building is leaning 2 inches in 4 feet. Options for additional support and bracing should be explored. Recommend a qualified structural engineer or foundation specialist evaluate further and remedy as needed. This could be costly.

Measuring on the east side of the building

Contact a qualified general contractor.

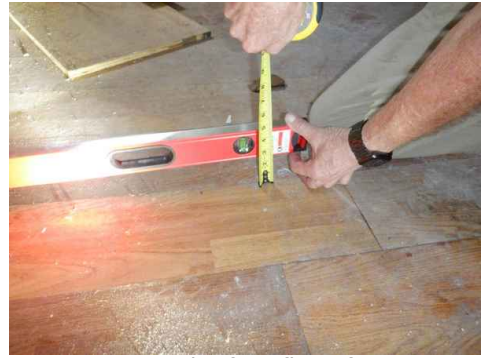
Measuring on the first floor front room.

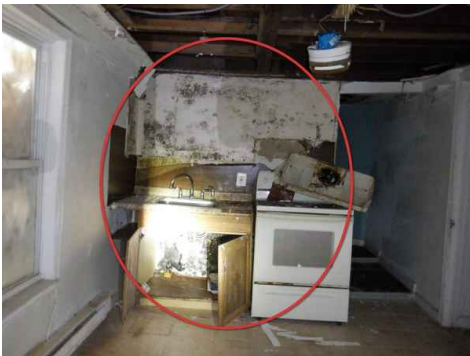
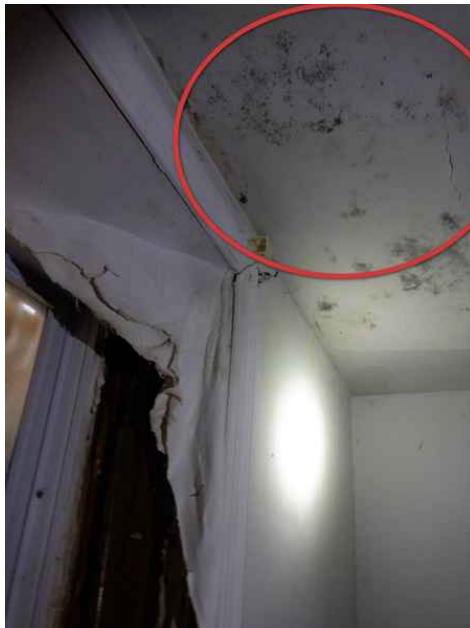
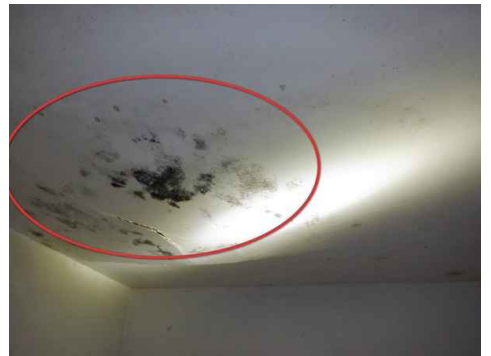
3.3.5 Beams, Columns, & Joists

MICROBIAL ACTIVITY

Observed signs of microbial like stains in one or more areas in the floor structure. Recommend identifying moisture source and repair to stop moisture intrusion. Recommend hiring a Mold Assessor for lab testing.

Contact a qualified mold inspection professional.

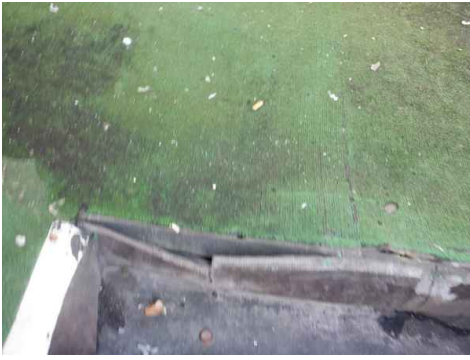
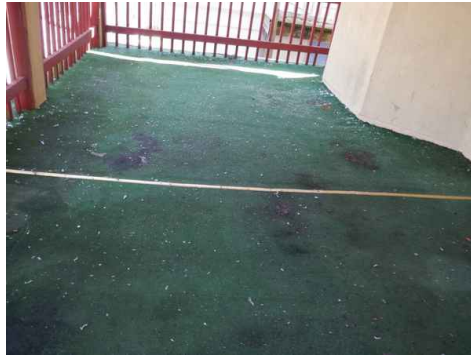
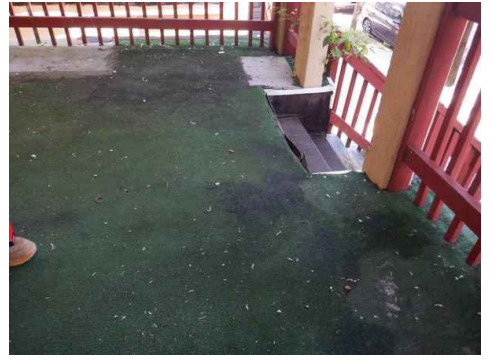
4.1.1 Decks, Balconies, Porches & Steps

MAJOR DAMAGE FLOORING

One or more portions of the flooring were showing signs of deterioration or rot. Recommend a qualified contractor replace.

Recommendation
Contact a qualified carpenter.

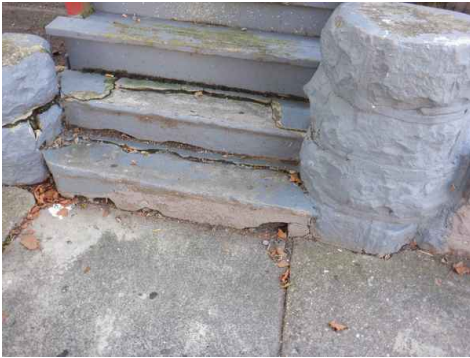
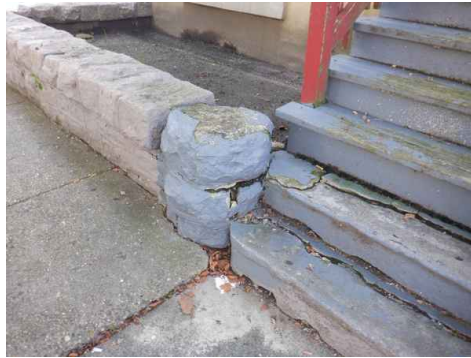
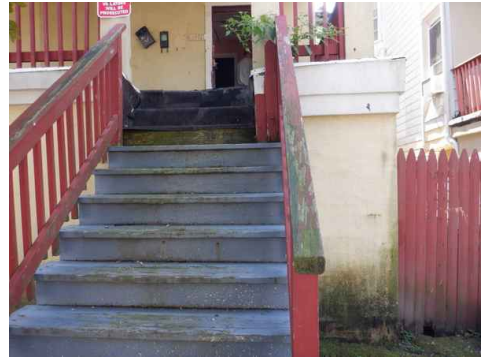
4.1.2 Decks, Balconies, Porches & Steps

STAIRS - DAMAGED

One or more sections of the exterior stairs are damaged. Recommend qualified contractor evaluate & repair prior to use.

Contact a qualified carpenter.

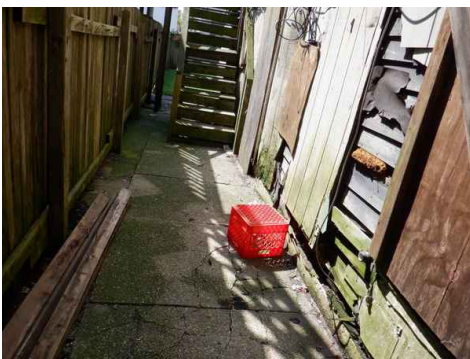
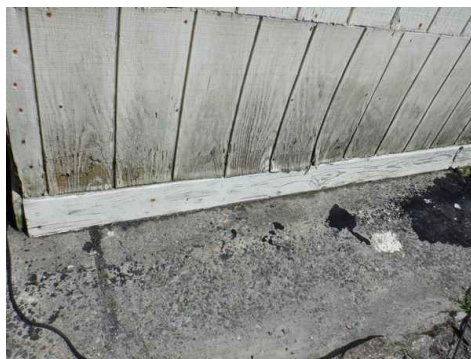
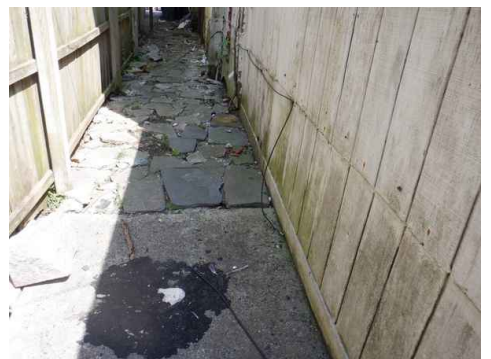
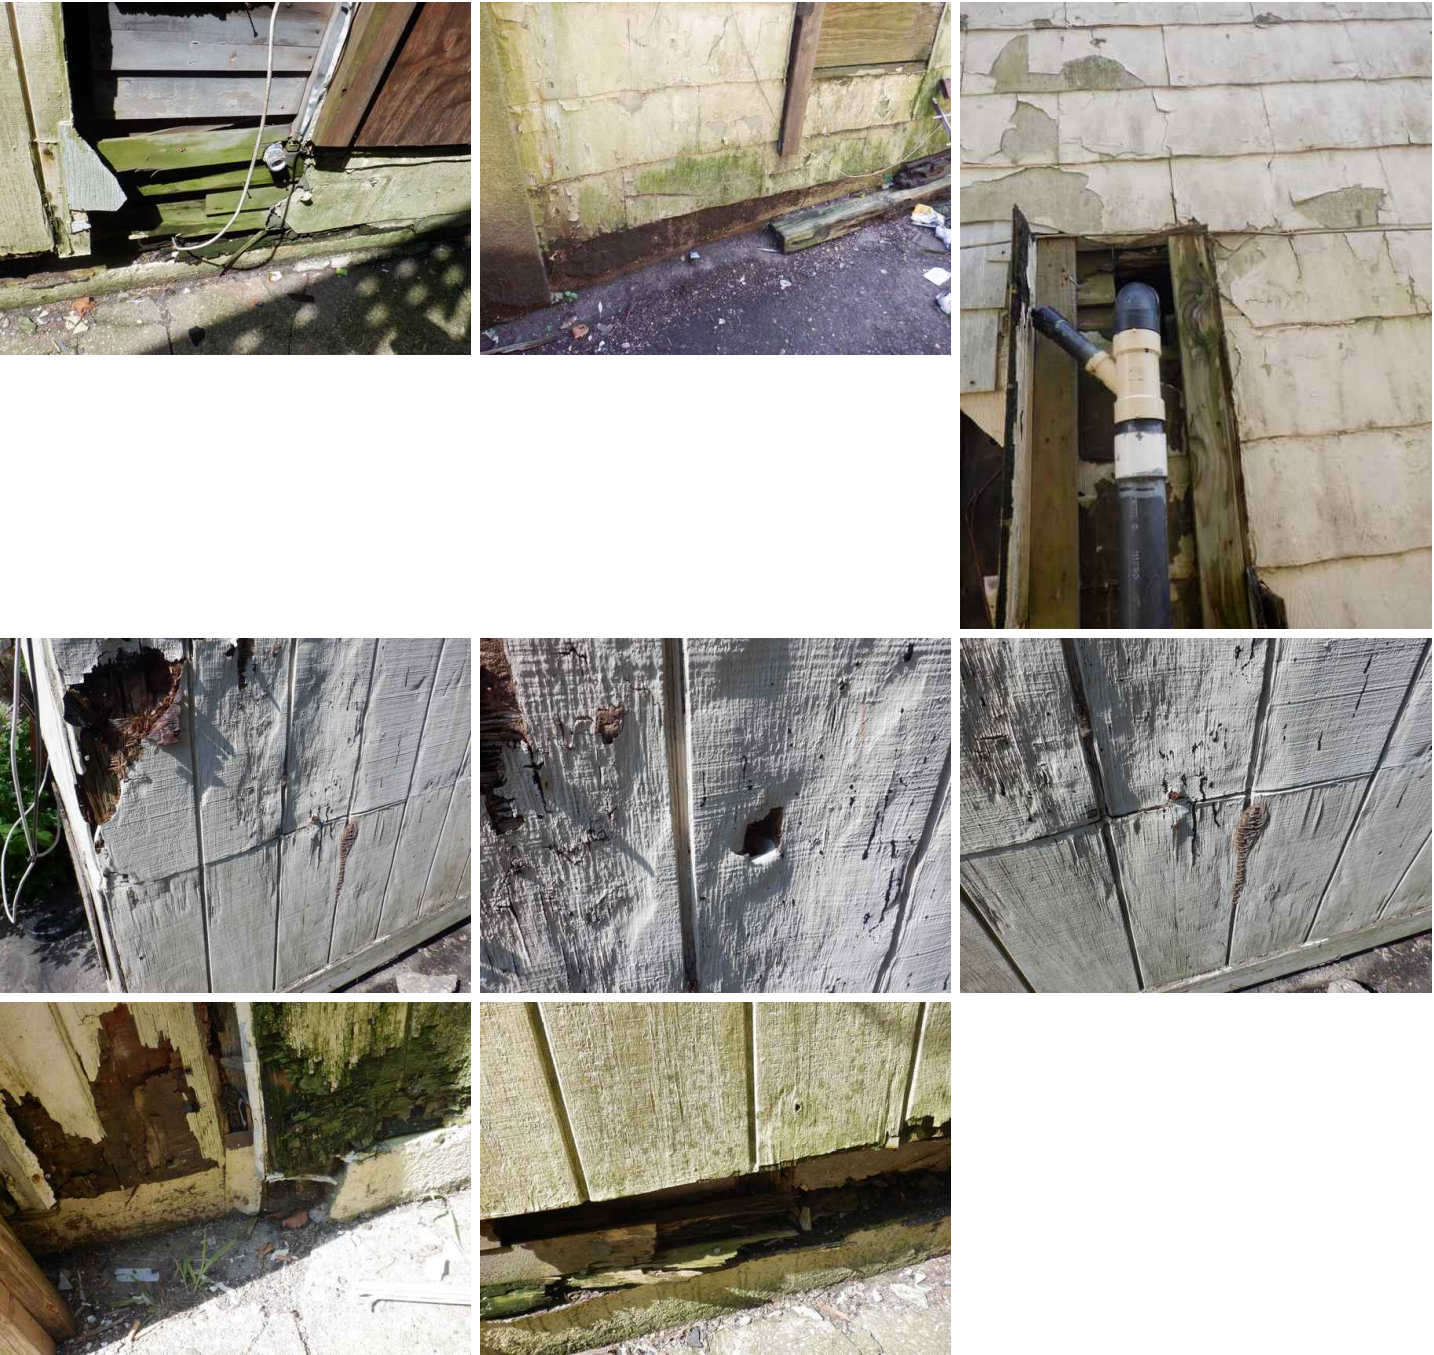
4.2.1 Wall Covering

MAJOR DAMAGE

Moderate to major damage was observed at one or more points on the exterior wall covering. Recommend repair soon. This can be costly.

Contact a qualified siding specialist.

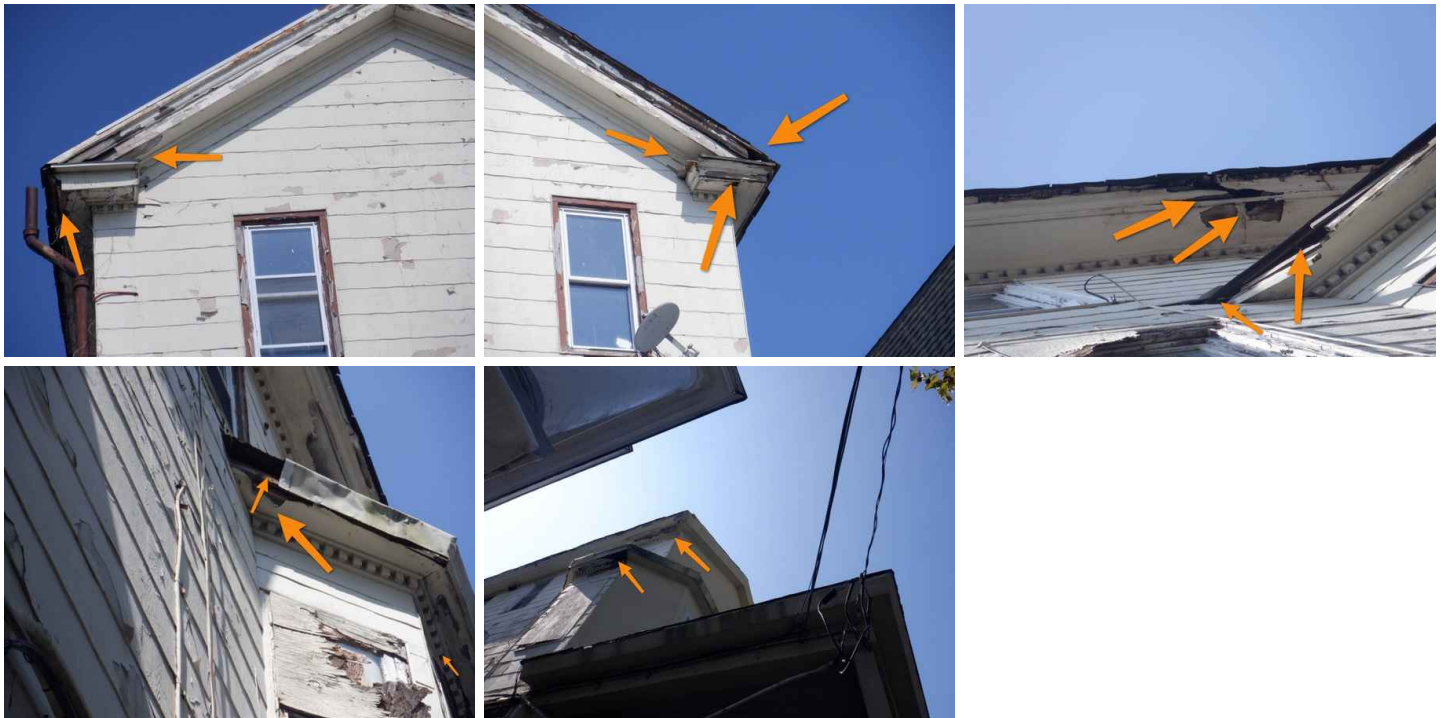
4.4.1 Eaves, Soffits & Fascia

GAPS / HOLES

There was an opening, gap, or a hole in fascia / soffit area which should be repaired. This can allow water intrusion and rodent infestation as well as deterioration of the surrounding material.

Contact a qualified carpenter.

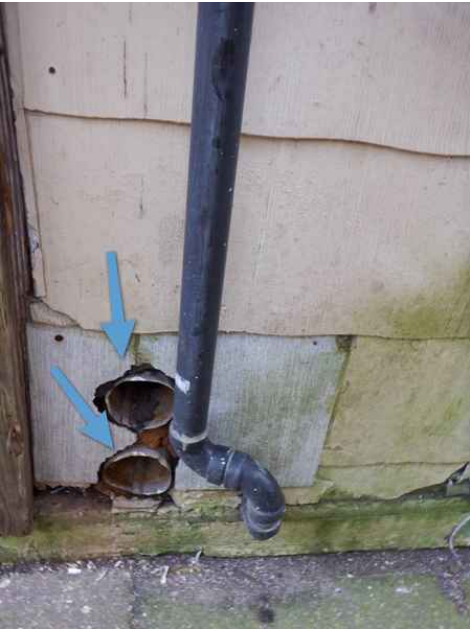
4.5.1 Exterior Vents

DAMAGED VENT

I observed an exhaust hood or vent that was damaged. Recommend repair.

Recommended DIY Project

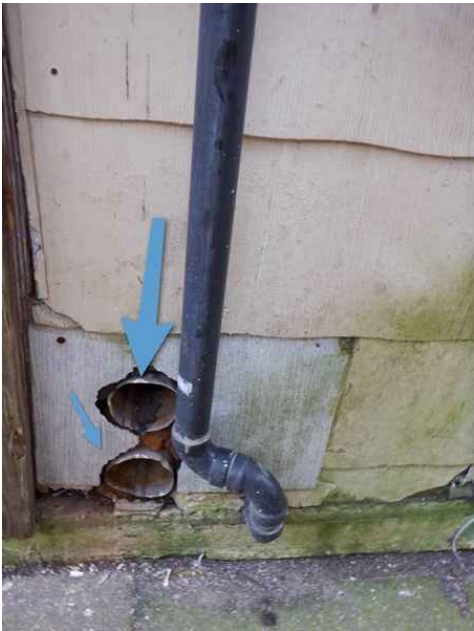
4.5.2 Exterior Vents

**DRYER VENT
CLEARANCE**

The dryer exhaust hood or exhaust duct outlet vent had inadequate clearance from an air inlet or from snow buildup. The wall cap should include a flap or damper that closes when the fan is not exhausting. The wall cap may come with a screen or grille to keep out birds and other animals. The exhaust air should not be directed onto a walkway.

Contact a qualified appliance repair professional.

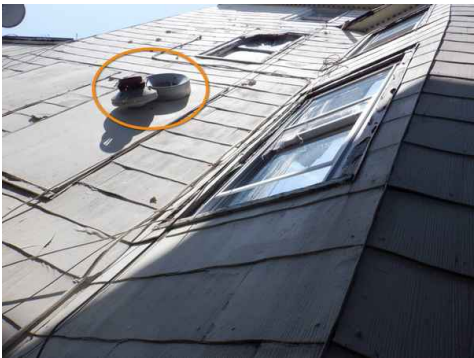
4.6.1 Lighting, Fans, Switches, &
Receptacles

FAN INOPERABLE

The fan was inoperable. Recommend a licensed electrician evaluate further.

Contact a qualified electrical contractor.

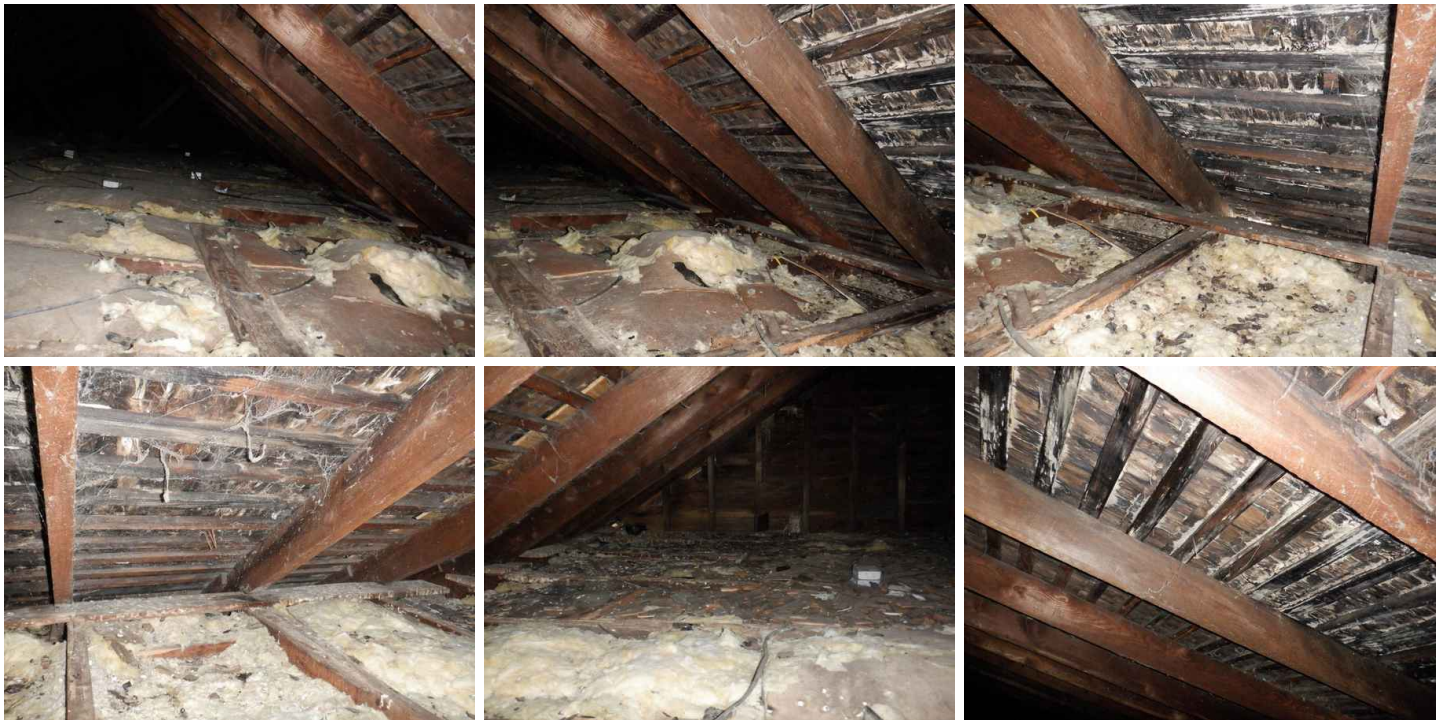
5.3.2 Roof & Attic Structure

WATER DAMAGED

Some components were water damaged. Recommend repair or replacement of damaged sections as needed.

Contact a qualified roofing professional.

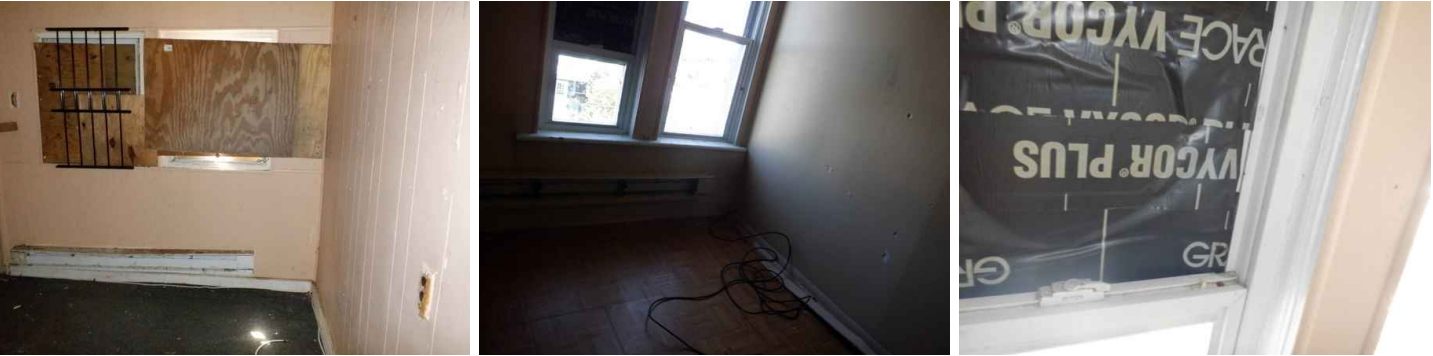
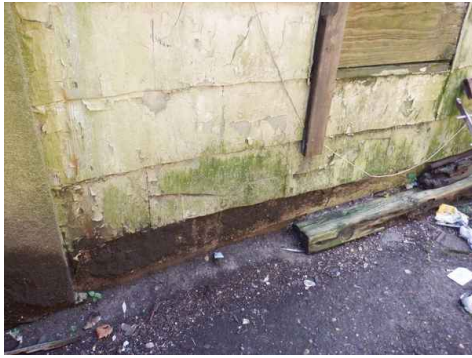
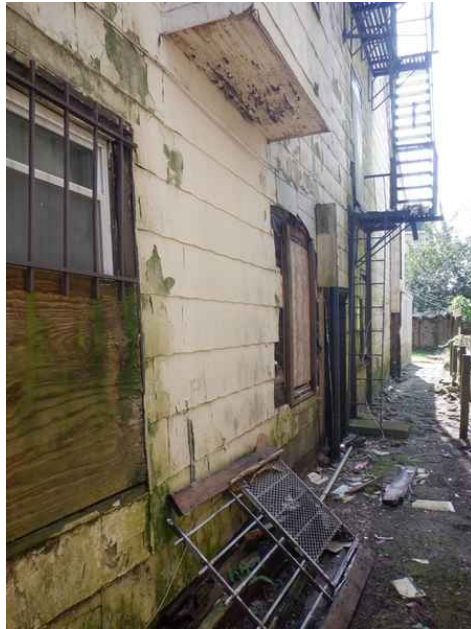
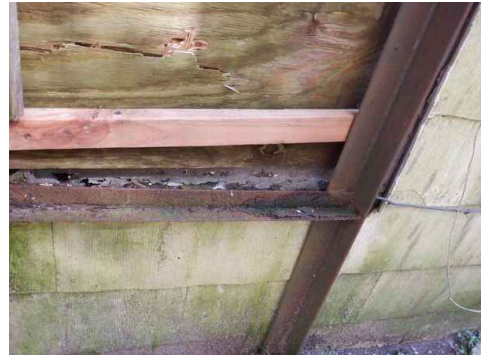
6.1.1 Doors & Windows

ALL WINDOWS AND DOORS ARE IN NEED OF REPLACEMENT.

Most are boarded up and not operable.

Contact a qualified professional.

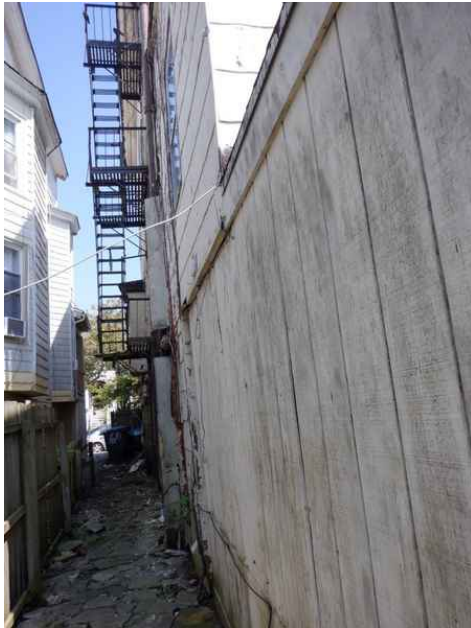
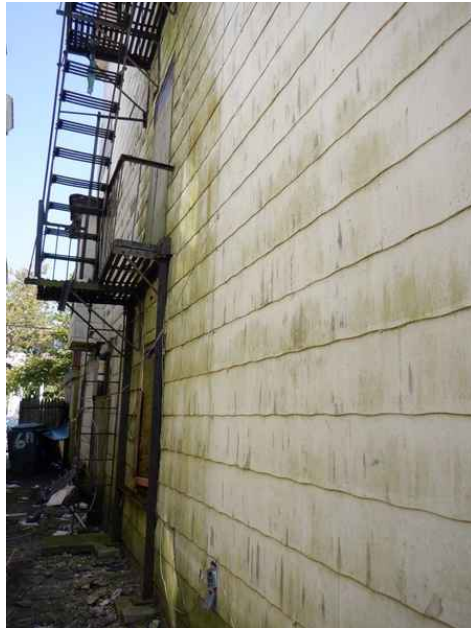
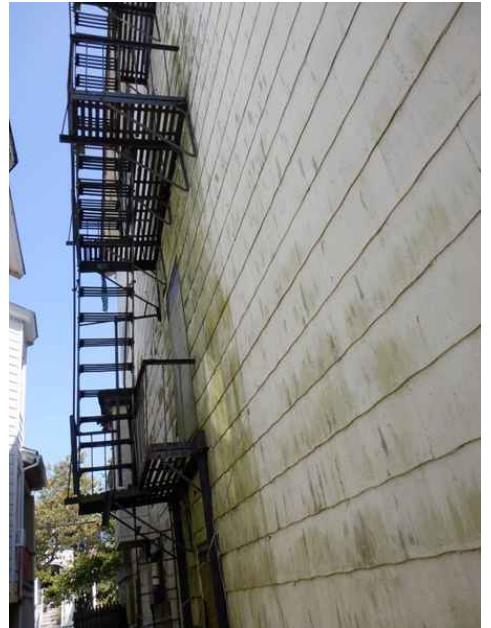
FIRE ESCAPE WAS NOT TESTED DUE TO THE ITS CONDITION

The fire escape was not tested due to the deteriorated condition of it and the building it's attached to.

Contact a qualified professional.

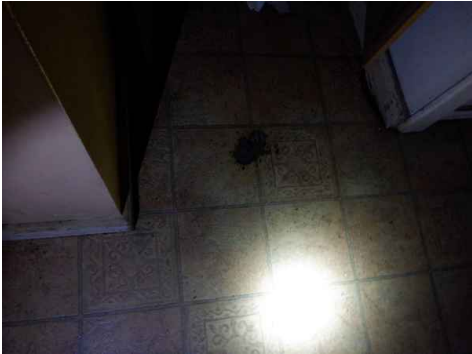
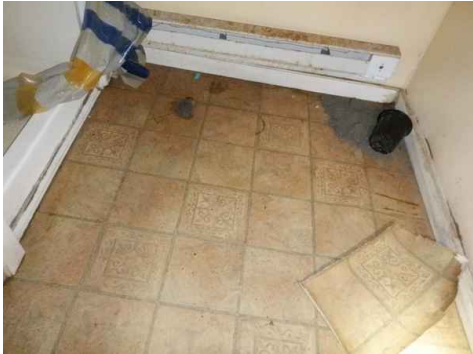
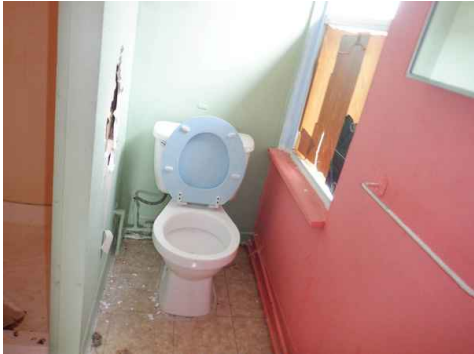
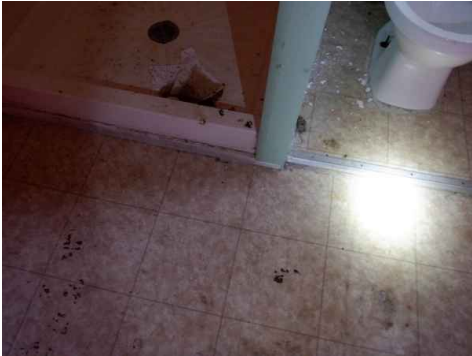
12.1.1 Hazardous materials

Untreated human excreta contain many pathogens and disease-causing microbes like cholera, diarrhea, typhoid, polio, meningitis, hepatitis, etc. The germs of these diseases can easily reach the human population through air, water, or insects and through contaminated food and water. We recommend immediate cleanup and securing the building so no one can get in.

Contact a qualified professional.
