## ANDREWS COMMERCIAL INSPECTION REPORT

1234 Main Street Mays Landing, NJ 08330

> Buyer Name 11/12/2023 9:00AM

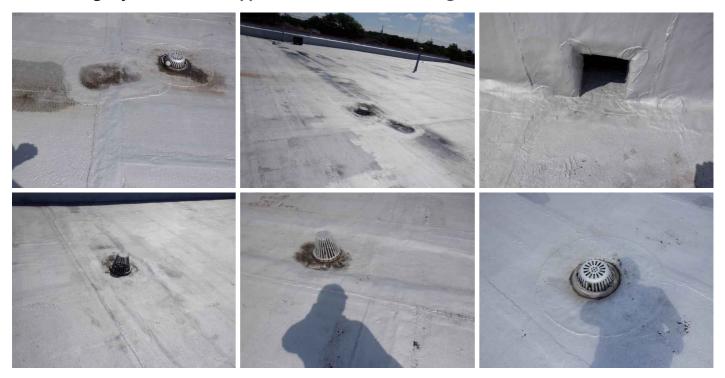
#### **Roof Drainage Systems:** Roof Scuppers are used for roof drainage

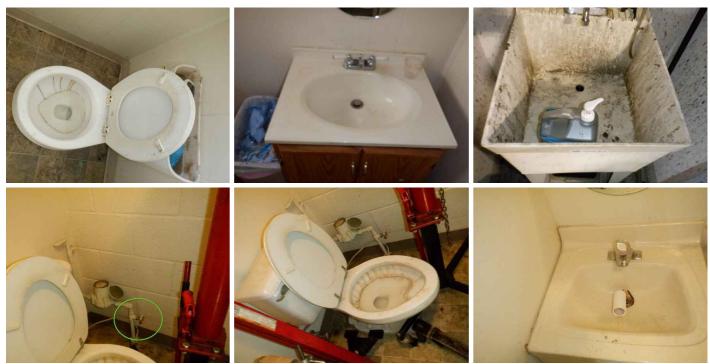
This unit has 2 bathrooms

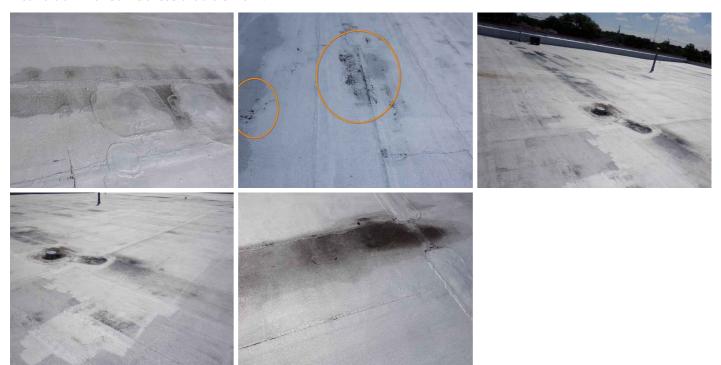
### Coverings: Recoating is recommended in the not to distant future

Having the roof surface recoated with the silver coat will extend the useful life of the roof materials. It is in useable condition with some areas that it is worn.
