ANDREWS PROPERTY INSPECTIONS LLC

COMMERCIAL PROPERTY INSPECTION

1234 Main Street
Mays Landing, NJ 08330

Buyer Name
11/12/2023 9:00AM

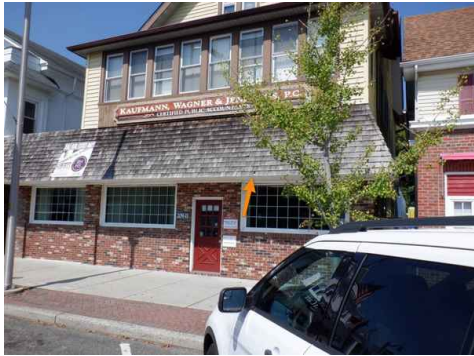
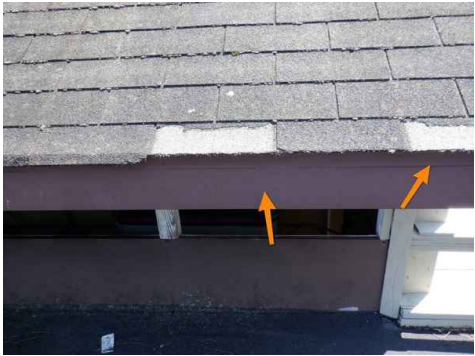
3.1.1 Coverings
MISSING SHINGLES

I observed 2 areas where there are missing shingles.

This is the roof over the air conditioning condensers.

Recommendation
Contact a qualified professional.

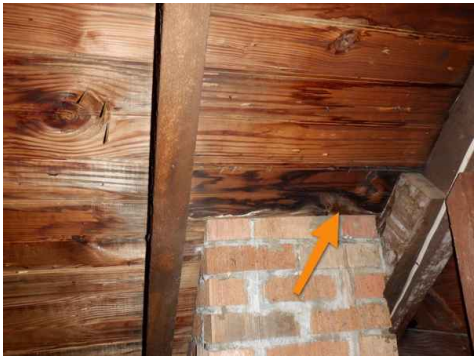
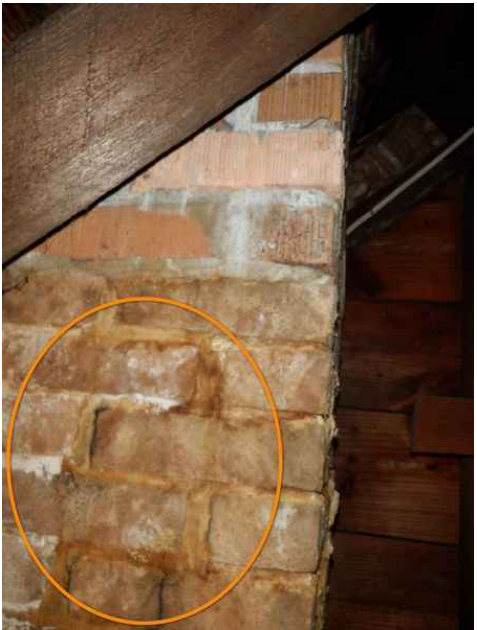
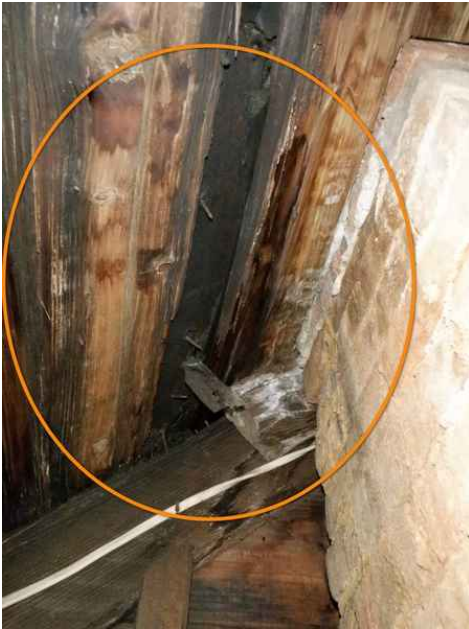
3.2.1 Flashings, Chimneys & Roof Penetrations

The chimney flashing shows signs of leakage from the attic. I recommend evaluation and repairs by a qualified roofing contractor.

Contact a qualified chimney contractor.

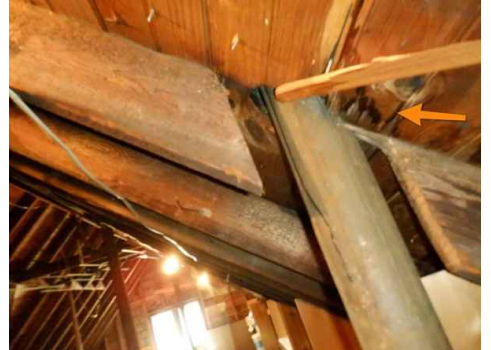
3.2.2 Flashings, Chimneys & Roof Penetrations

The roof rafter also needs to be repaired where it is cut to make room for the plumbing stack.

Contact a qualified professional.

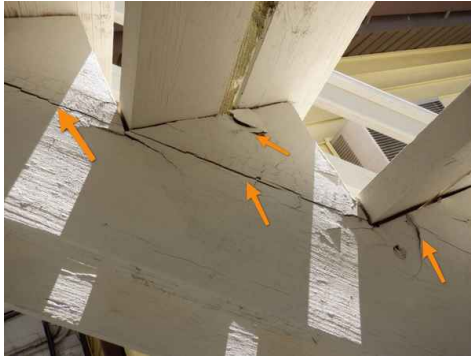
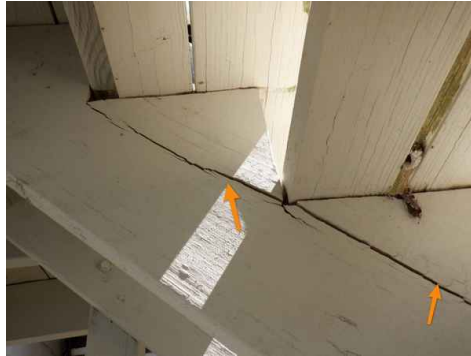
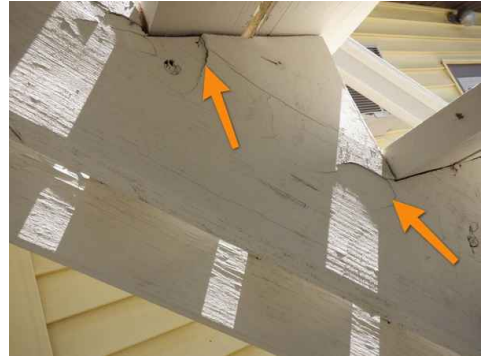
Wooden components of the deck and/or stairs were heavily weathered in areas. Decks require periodic maintenance including pressure washing and staining, and neglecting this maintenance can lead to water damage and compromise the integrity of the deck. Evaluation of this deck and repairs or replacement of any damaged wood, including framing members is recommended to be performed by a deck contractor.

Center stair horse is cracked and in need of replacement.

Contact a qualified professional.

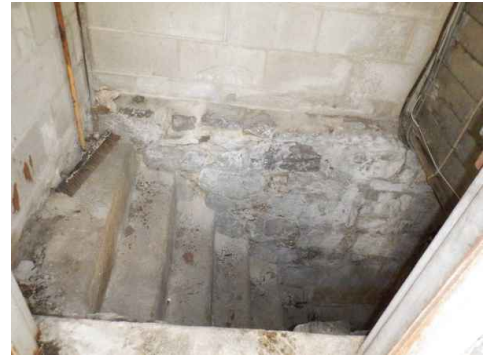
4.1.2 Decks, Balconies, Porches & Steps

There is no landing when you open the basement door, it goes directly to open stairs. I recommend evaluation and repairs by a qualified contractor.

Contact a qualified professional.

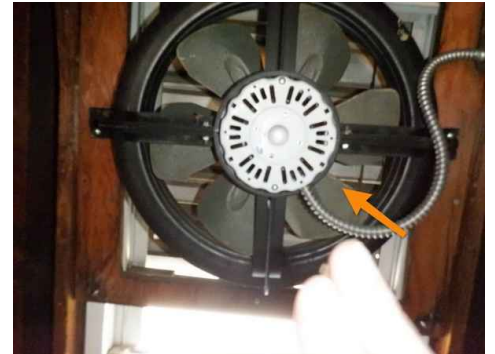
Attic venting was insufficient at time of inspection. Modern standards recommend 1.5 square feet of venting area for every 300 square feet of attic floor space. Recommend an attic contractor evaluate and remedy.

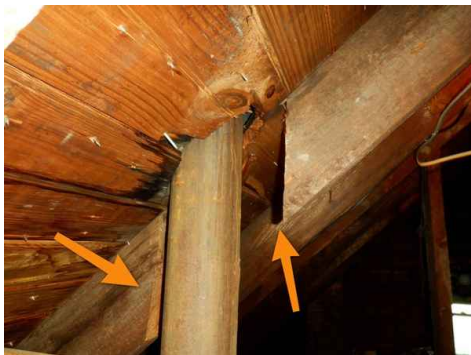
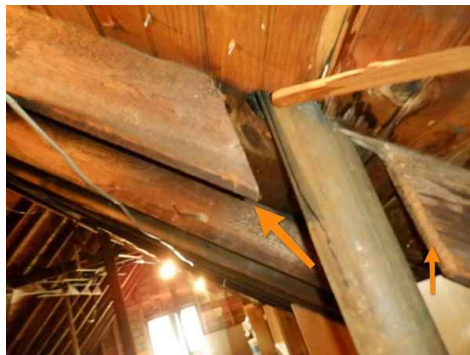
5.3.1 Roof & Attic Structure

I observed a roof rafter that was cut to make room for a plumbing stack. I recommend it be repaired to prevent any roof sag in that area.

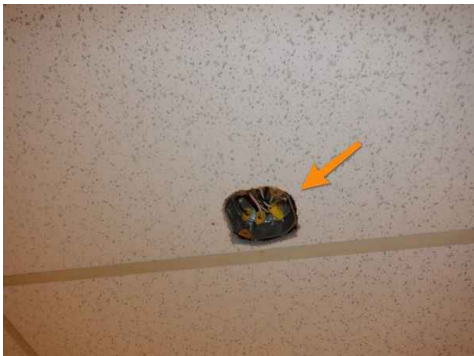
MISSING COVER PLATES

I observed one or more missing cover plates, I recommend they be installed to prevent an electrical shock or electrocution.

Recommendation
Contact a qualified professional.

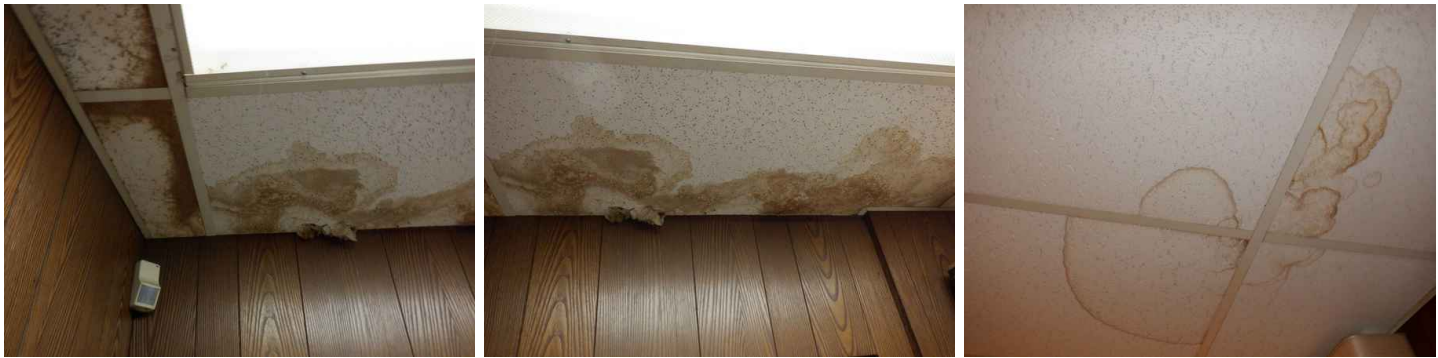
6.4.1 Walls and Ceilings

Some ceiling tiles were damaged. Recommend repair or replacement as needed. Any water-stained tiles should warrant further investigation to ensure no leaks exist. There didn't appear to be any active water leaks.

Recommendation
Contact a qualified general contractor.

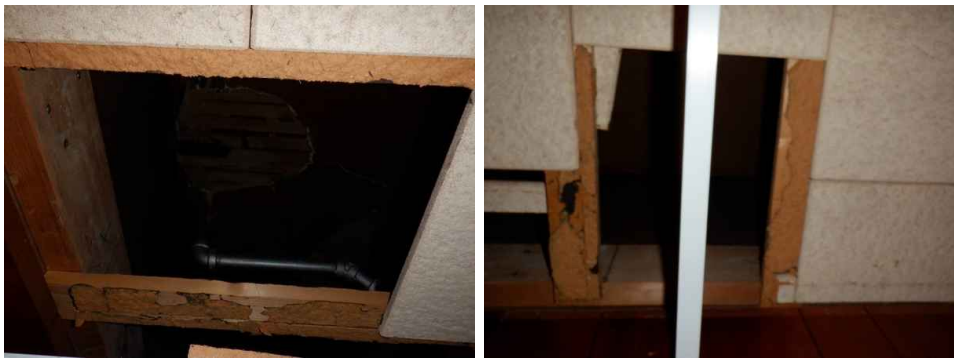
6.4.2 Walls and Ceilings

I observed holes cut into the ceiling on the second floor, probably for repair work. I recommend they be repaired for a better appearance and cut done on drafts.

Recommendation
Contact a qualified professional.

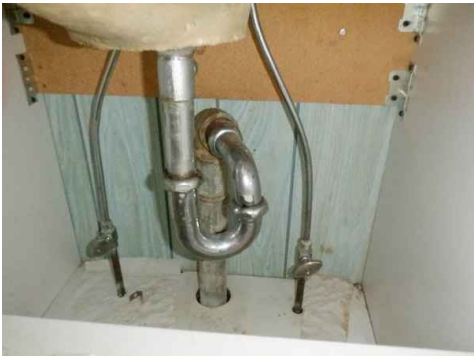
7.4.1 Plumbing Related

An "S" trap(s) was present. "S" traps are no longer standard practice as the water "seal" may siphon out of the trap, allowing sewer gases to enter the building. Replacement with a "P" trap is recommended by a licensed plumber.

Contact a qualified professional.

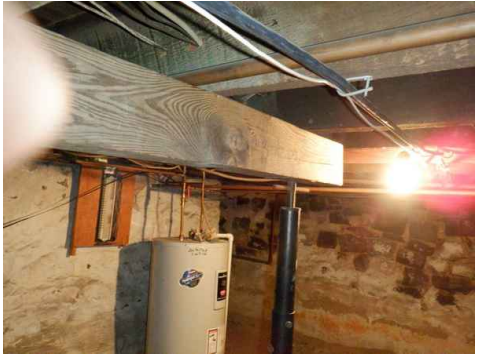
Temporary columns have been employed. Recommend a qualified contractor evaluate and install permanent column supports as needed.

Contact a qualified general contractor.

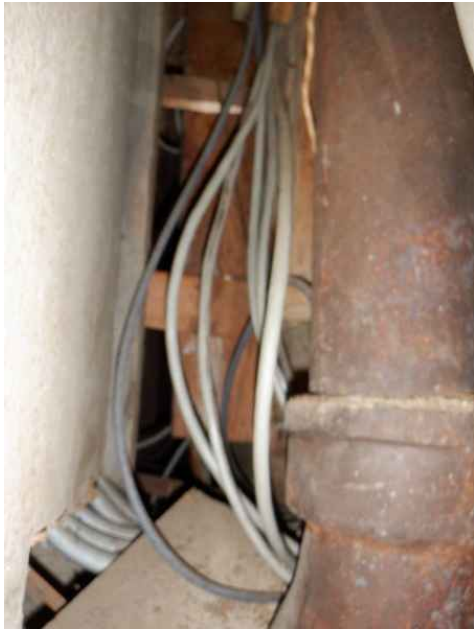
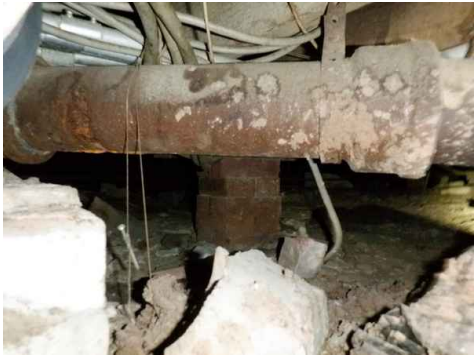
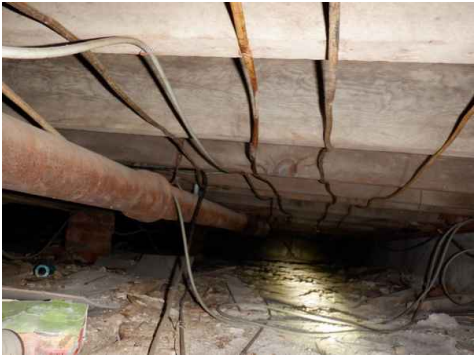
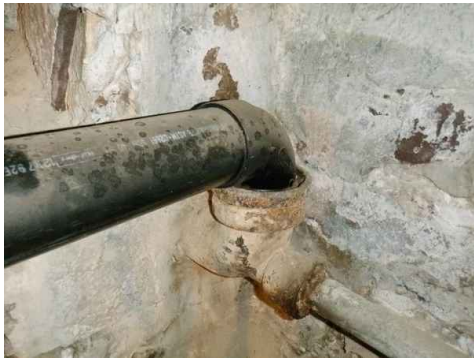
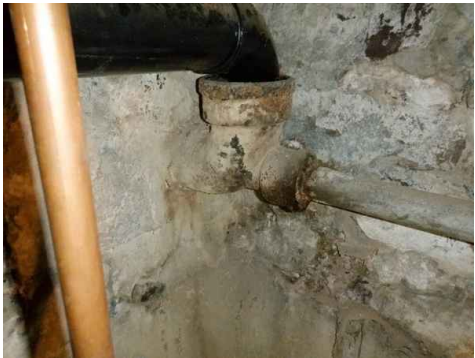
The sewer/septic lateral exiting the home was comprised of cast iron. Cast iron typically has a 50 - 60 year life, and will eventually develop inner corrosion that will affect the draining functionality of the system, and cause failure. These pipes will need to be monitored for performance, with the understanding that major repairs or replacement will be needed at some point in the future due to their age. The remaining life is undeterminable. **A sewer cam inspection of the pipes is highly recommended to be conducted by a licensed plumbing contractor due to their age.**

Contact a qualified professional.

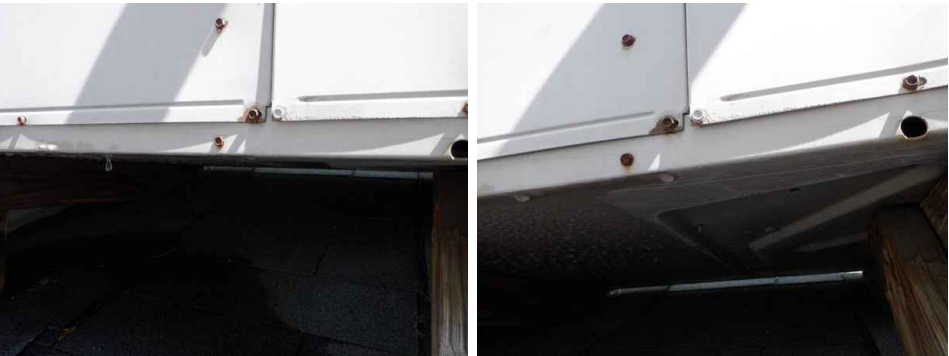
SMALL PACKAGE UNIT IS LEAKING WATER

I observed that the small package unit for the side addition was leaking condensate out of the cabinet instead of the drain. I recommend service by a qualified HVAC contractor.

Contact a qualified professional.

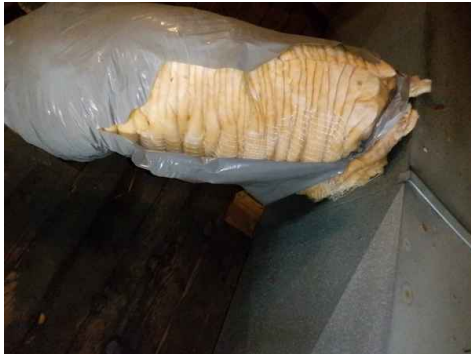
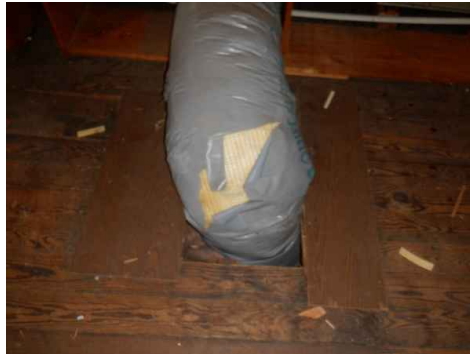
10.3.1 Distribution Systems

Air duct was damaged. Recommend a qualified HVAC contractor repair.

Contact a qualified heating and cooling contractor

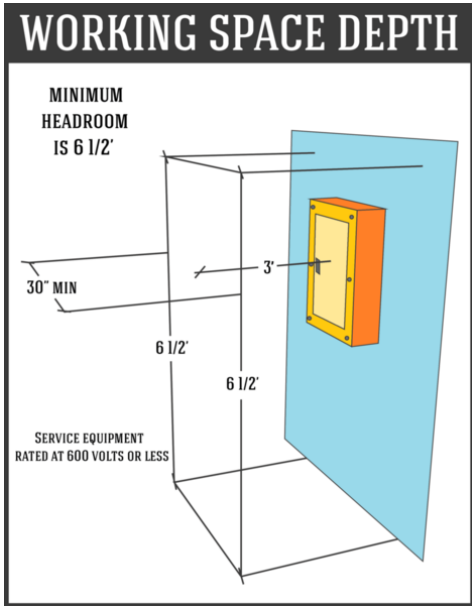
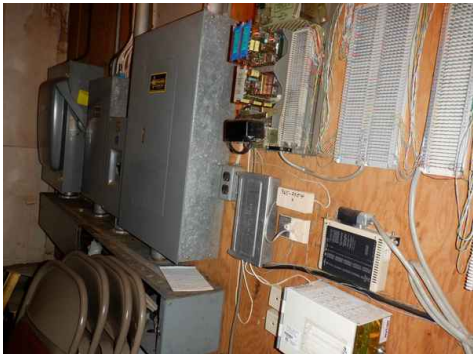
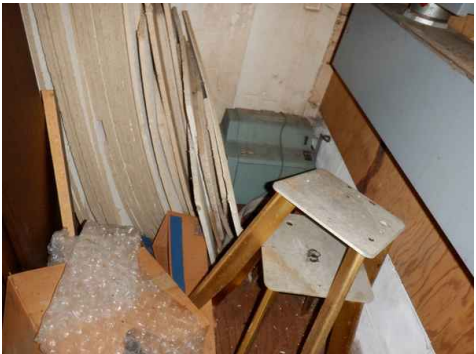
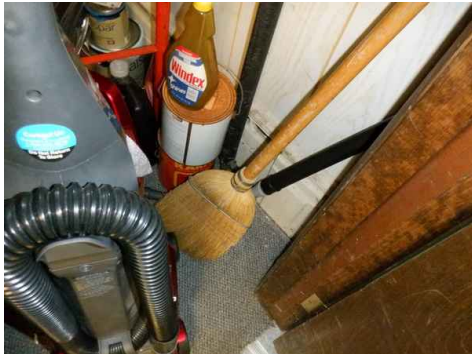
PANEL CLEARANCE

The clearance around the panel limited a full inspection. Recommend modifications for access.
