ANDREWS PROPERTY INSPECTIONS LLC

ANDREWS COMMERCIAL INSPECTION REPORT

1234 Main Street
Mays Landing, NJ 08330

11/12/2023 9:00AM

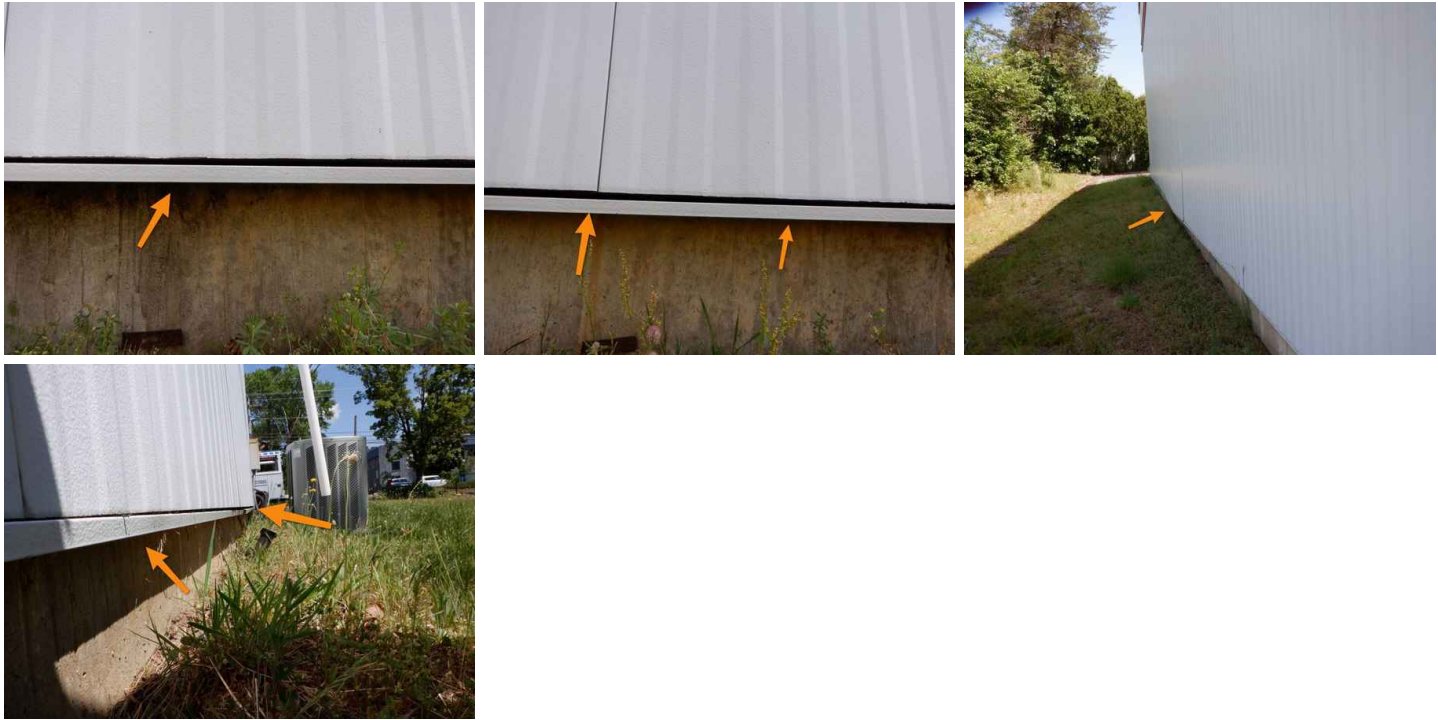
2.3.1 Siding, Flashing & Trim

SIDING PUSHED OUT IN ONE OR MORE LOCATIONS

I observed some of the siding that was pushed out from the foundation. I recommend it be repaired by a steel siding contractor.

Recommendation
Contact a qualified professional.

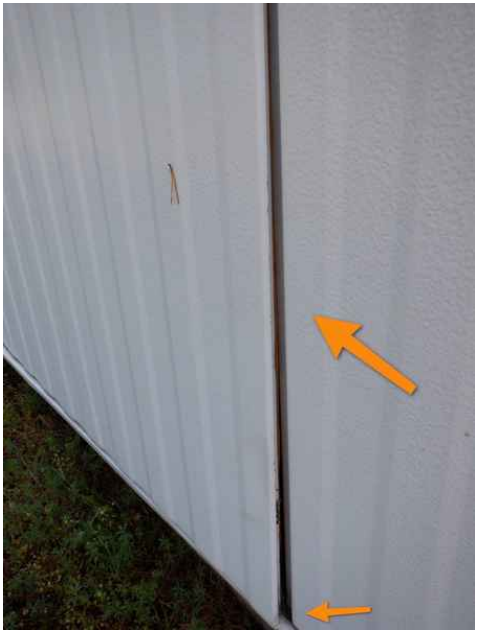
2.3.2 Siding, Flashing & Trim

STEEL PANEL SEAM OPENING UP

I observed a seam on the panels on the west side of the building is opening up. I recommend repairs by a steel siding contractor.

Contact a qualified professional.

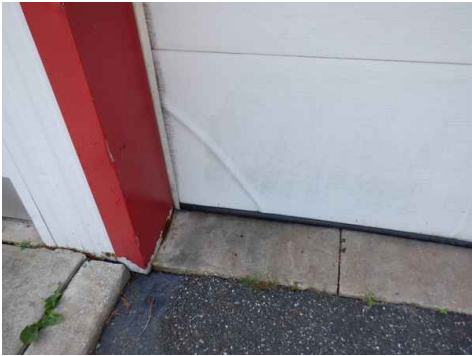
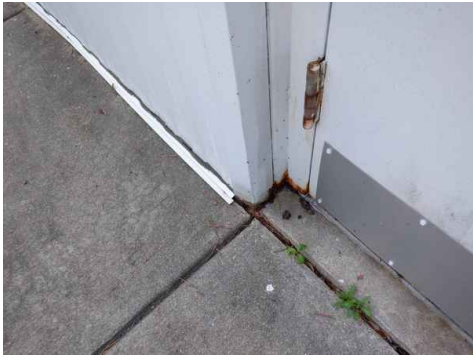
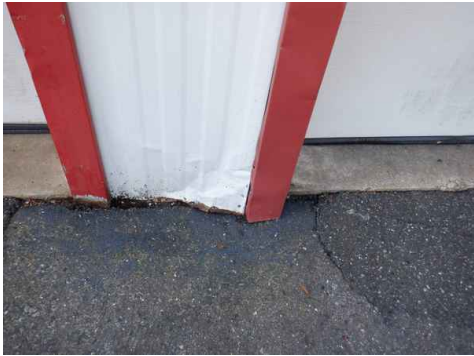
2.3.3 Siding, Flashing & Trim

SOME RUSTING AROUND THE BOTTOM OF THE STEEL PANELS

Where the panels meet the concrete sidewalks and driveways, the steel is starting to rust on the very bottom. Evaluation and repair by a siding contractor is recommended. Preventative maintenance will make the panels hold up better to the elements.

Contact a qualified professional.

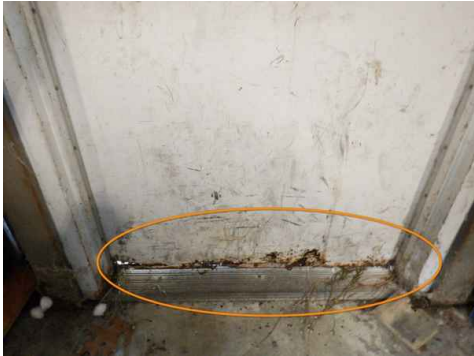
2.5.1 Exterior Doors And Windows

DOOR IS DAMAGED

THE FAR LEFT HAND DOOR.

Exterior door is damaged recommend repair or replacement by a qualified professional.

Contact a qualified professional.

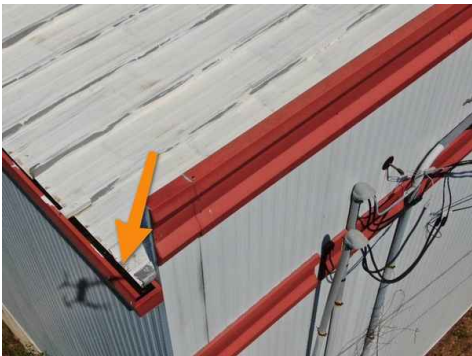
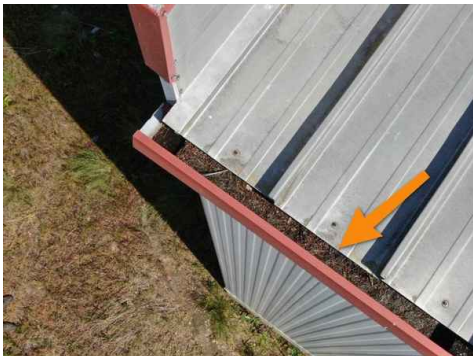
2.6.1 Roof Drainage Systems

DEBRIS

Debris has accumulated in the gutters. The water could build up enough to enter the building at the roof level. Recommend cleaning to facilitate water flow.

Contact a qualified roofing professional.

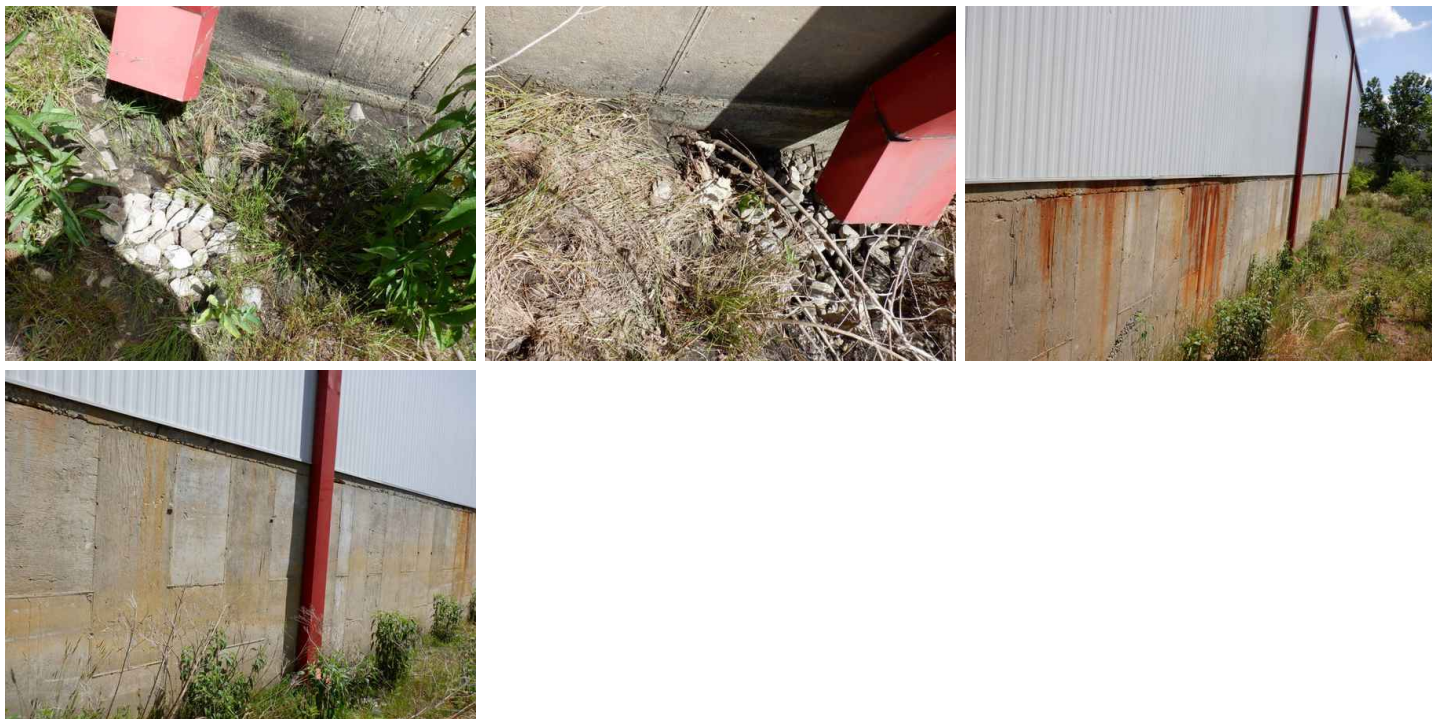
2.6.2 Roof Drainage Systems

DOWNSPOUTS DRAIN NEAR BUILDING

REAR OF THE BUILDING

One or more downspouts drain too close to the building's foundation. This can result in excessive moisture in the soil at the foundation, which can lead to foundation/structural movement. Recommend a qualified contractor adjust downspout extensions to drain at least 6 feet from the foundation.

Contact a qualified roofing professional.

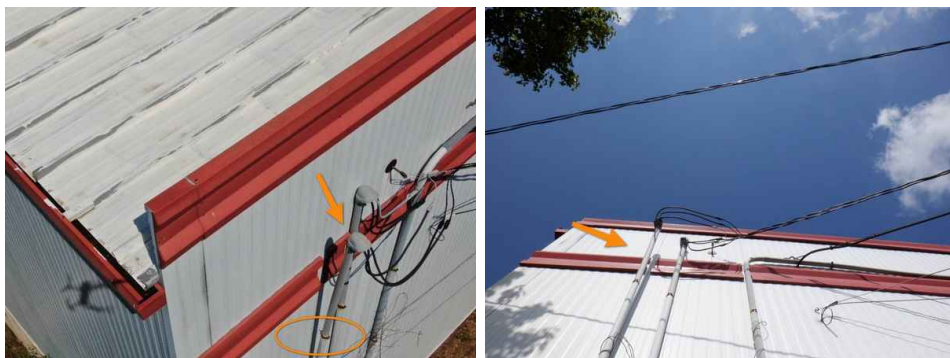
2.9.1 Electrical Service

SERVICE MAST COMING OFF THE BUILDING

I observed the electrical service mast is loose at the top and coming off the building..We recommend that the service mast be re secured to the building.

Contact a qualified professional.

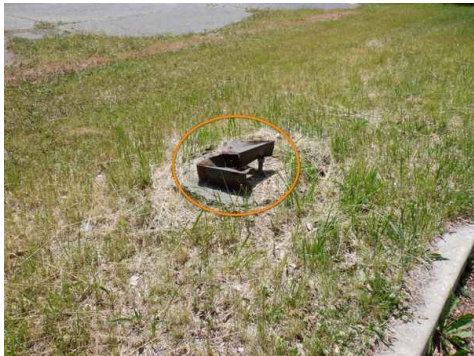
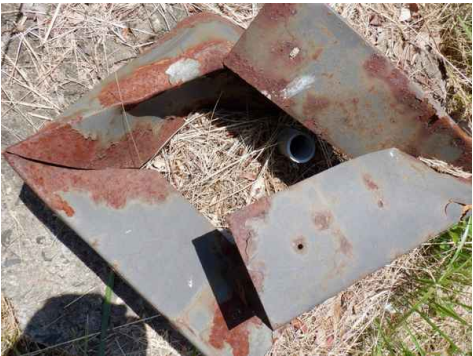
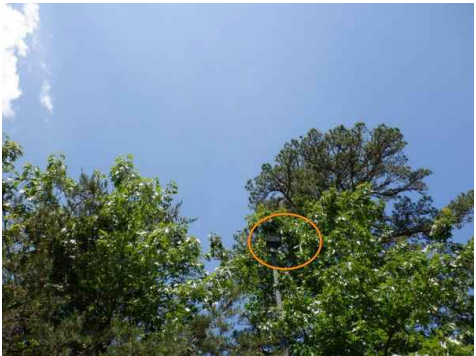
2.9.2 Electrical Service

EXTERIOR LIGHT AND POLE MISSING.

I observed the post light on the left side of the front parking lot is missing, apparently knocked down. The base and wire conduit are still there.

Contact a qualified professional.

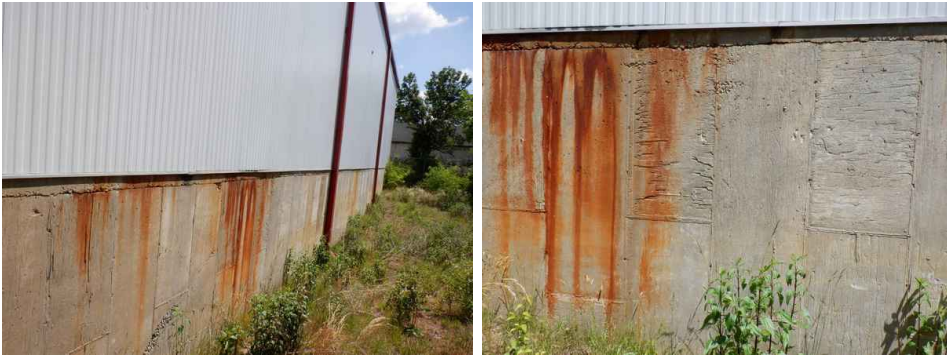
2.10.1 Foundation

RUST STAINS ON THE FOUNDATION

REAR WALL OF THE BUILDING

I observed one or more areas where there are large rust stains on the foundation wall leading me to believe there was water intrusion into the metal wall and framing inside behind the racks and supplies. Further evaluation is recommended.

Contact a qualified professional.

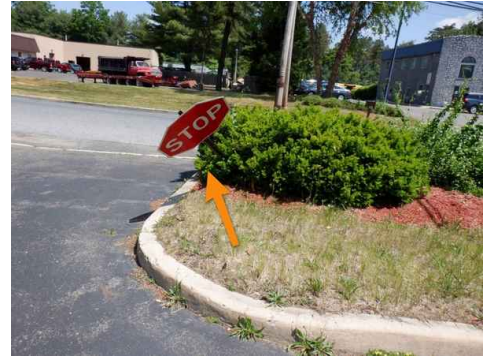
2.11.1 Parking Lot

PARKING LOT STOP SIGN HAS BEEN KNOCK OVER

The stop sign for the parking lot has been knocked over, I recommend it be repaired for the safety of all trying to exit the lot.

Contact a qualified professional.

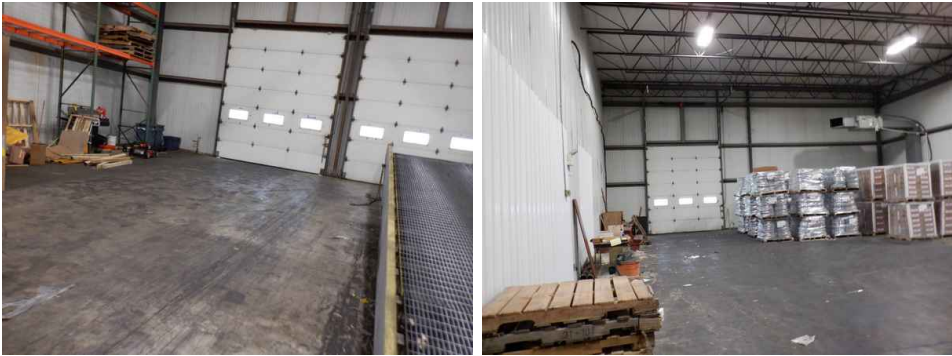
4.1.1 Floor STAINING

Garage floor shows visible staining from oil/grease. Recommend scrubbing with a degreaser or cleaning solution.

Recommendation
Recommended DIY Project

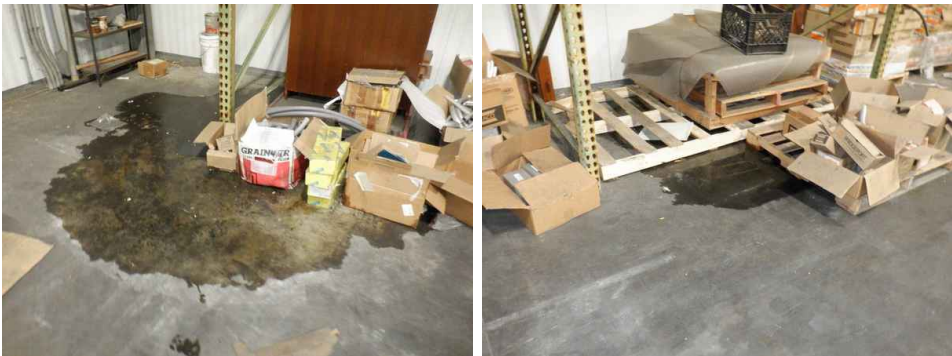
4.1.2 Floor

WET AREA ON THE FLOOR

I observed an area in the left rear corner that was wet. Inspection of the roof did not show any apparent cause for the wetness but could be from the chimney flashings on the roof or the gutters overflowing into the top of the wall. Examination during a rain would be helpful or evaluation by a roofing contractor.

Recommendation
Contact a qualified professional.

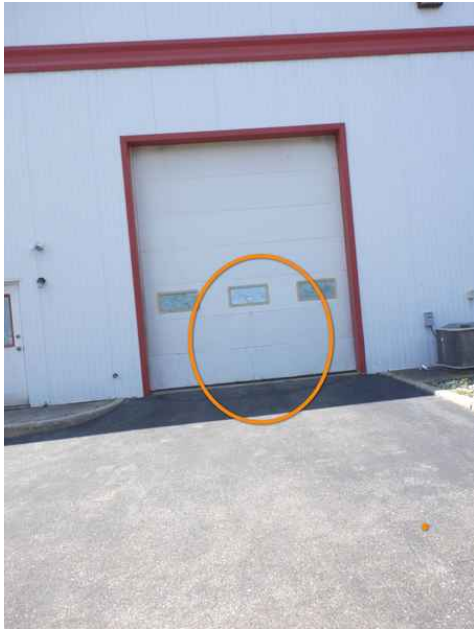
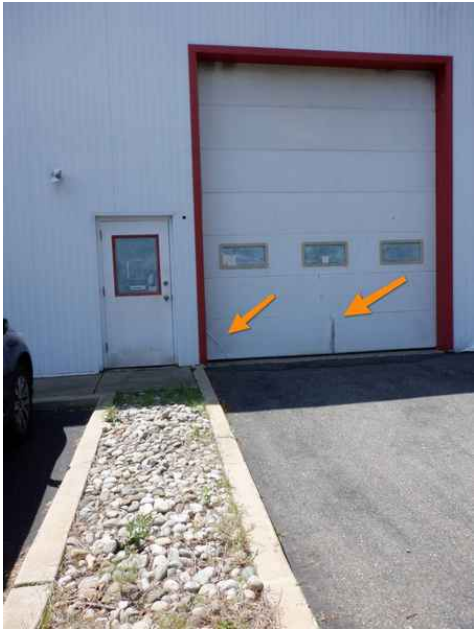
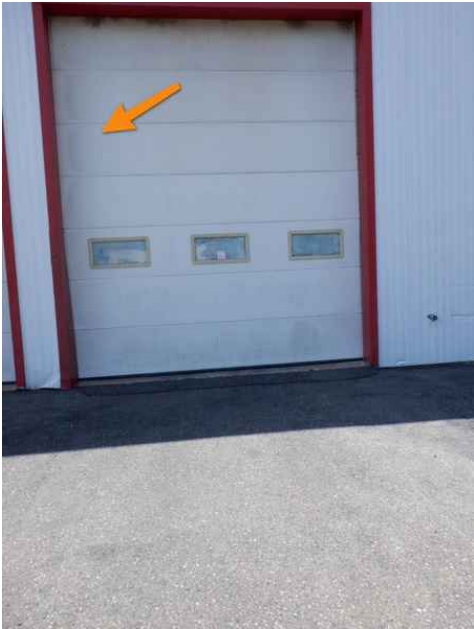
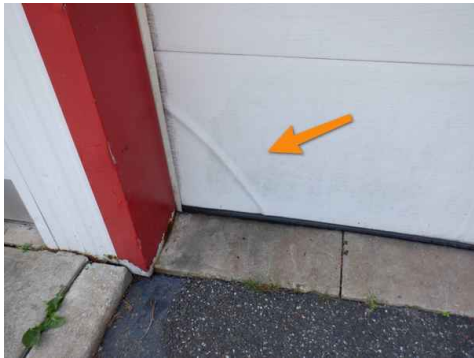
4.4.1 Overhead Door/s

GARAGE DOOR DAMAGED

The garage door has some damage or wear and tear recommend repair.

Recommendation
Contact a qualified garage door contractor.

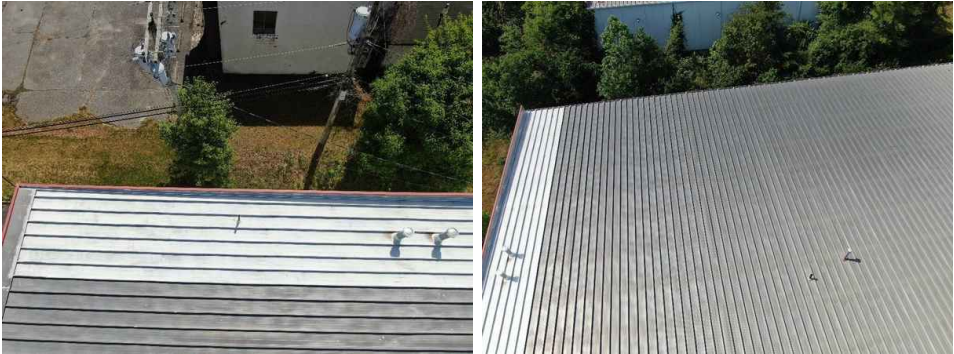
5.1.1 Coverings

A PORTION OF THE ROOF MATERIAL WAS COATED.

We observed that a small portion of the roof was coated and not the entire roof. I recommend inquiring from the seller as to the reason for this. Was this part of the roof replaced?

Recommendation
Contact a qualified professional.

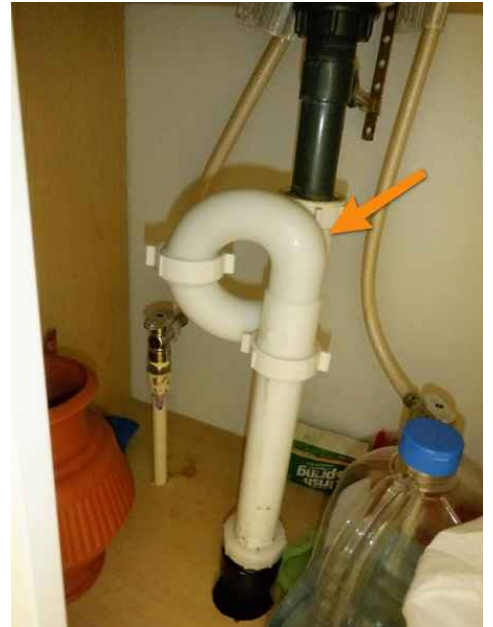
11.4.1 Drain, Waste, & Vent Systems

TRAP-S-TRAP PRESENT

An "S" trap(s) was present. "S" traps are no longer standard practice as the water "seal" may siphon out of the trap, allowing sewer gases to enter the building. Replacement with a "P" trap is recommended by a licensed plumber.

Contact a qualified professional.

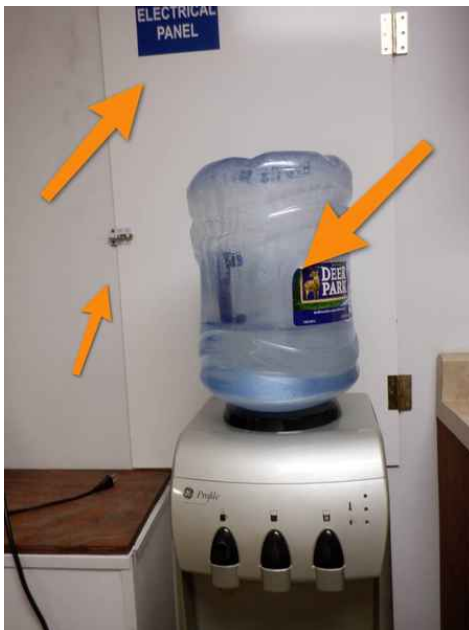
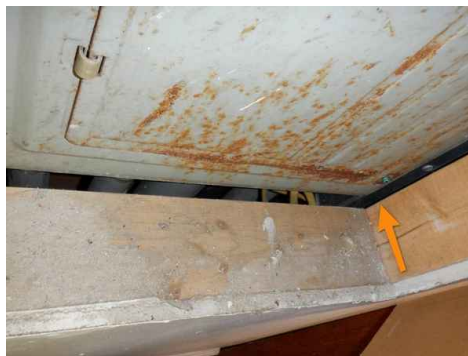
12.2.1 Main Panel

INADEQUATE CLEARANCE

A 3 foot by 3 foot square of clear space is required by most municipalities/countys recommend repair.

Contact a qualified professional.

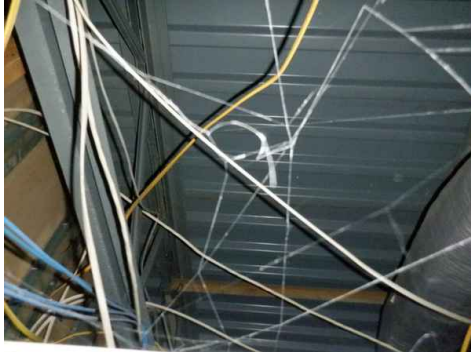
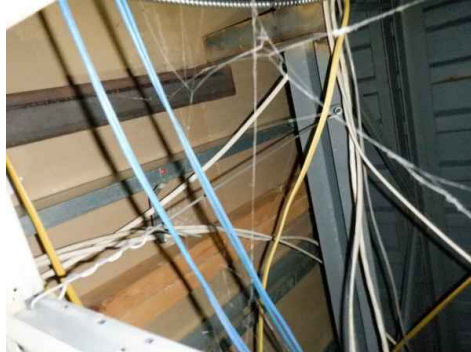
12.2.2 Main Panel

NM SHIELDED CABLE USED ABOVE DROPPED CEILING

NM Cable is prohibited above a dropped ceiling as early as 2004. I recommend evaluation by a Licensed Electrician.

Contact a qualified professional.

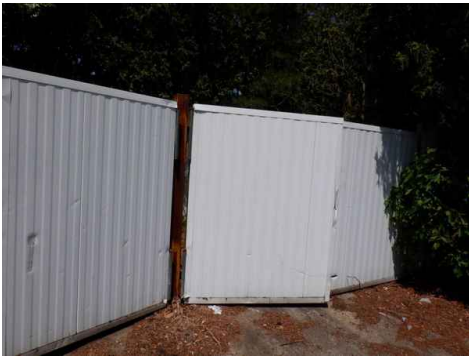
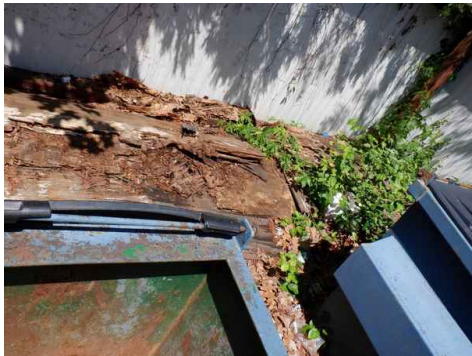
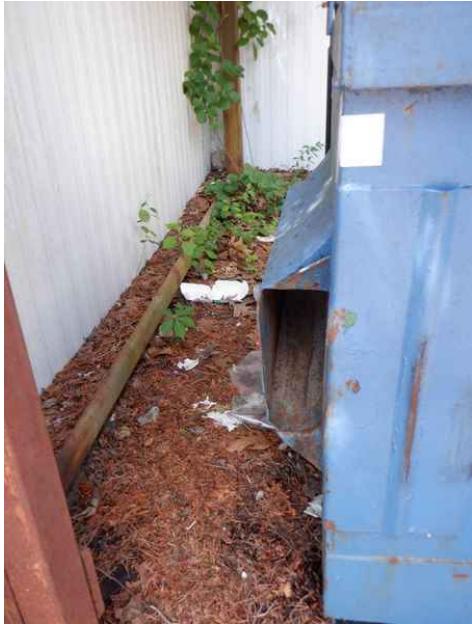
Dumpster Enclosure is in need of cleaning.
