## ANDREWS COMMERCIAL INSPECTION REPORT

1234 Main Street Mays Landing, NJ 08330

> Buyer Name 11/12/2023 9:00AM

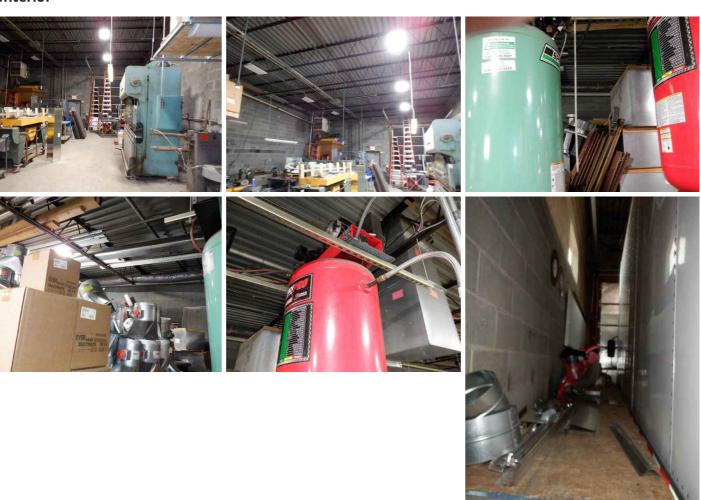
### Interior

The gas furnace is up in the upstairs storage area and the condenser is on the roof. They were manufactured in 2019. The age of the warehouse furnace was not available but looks to be a newer Lennox.
