ANDREWS PROPERTY INSPECTIONS LLC

COMMERCIAL PROPERTY INSPECTION

1234 Main Street
Mays Landing, NJ 08330

Buyer Name
11/12/2023 9:00AM

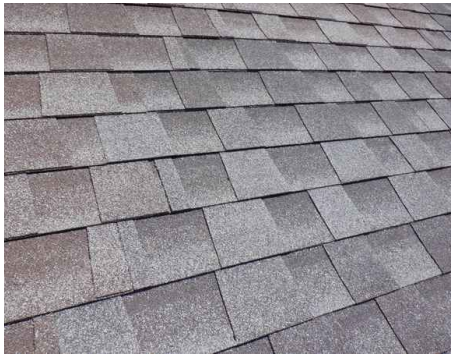
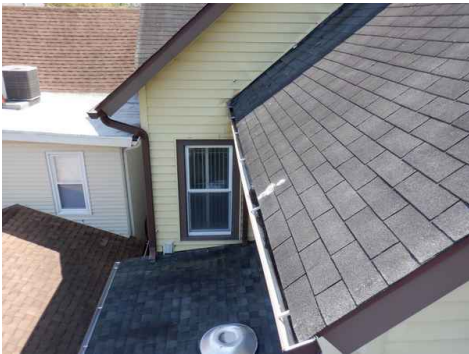
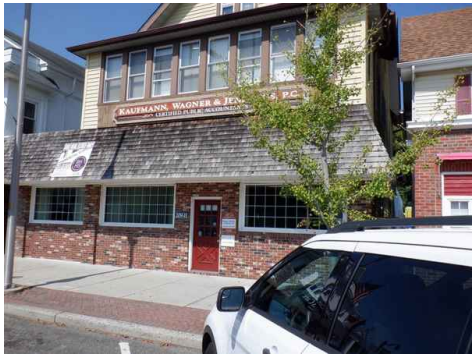
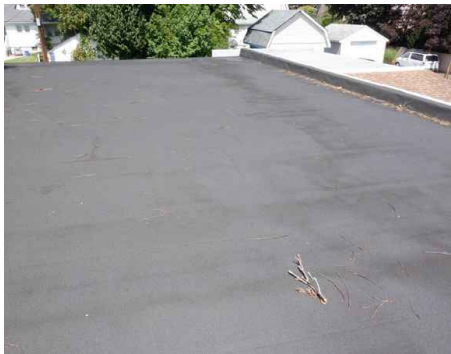
Coverings: Different roof shingles

I observed different types of roof shingles on this building. The south side of the building has architectural shingles, the north side has 3 tab fiberglass shingles and the facade out front has cedar shakes. The rear flat roof has modified bitumen roof covering.

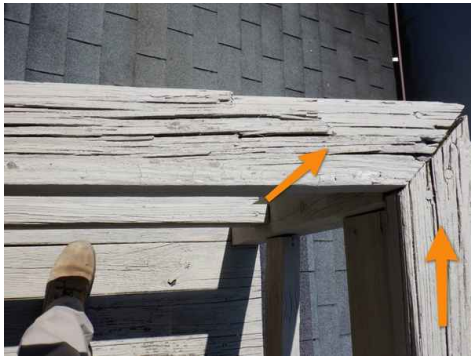
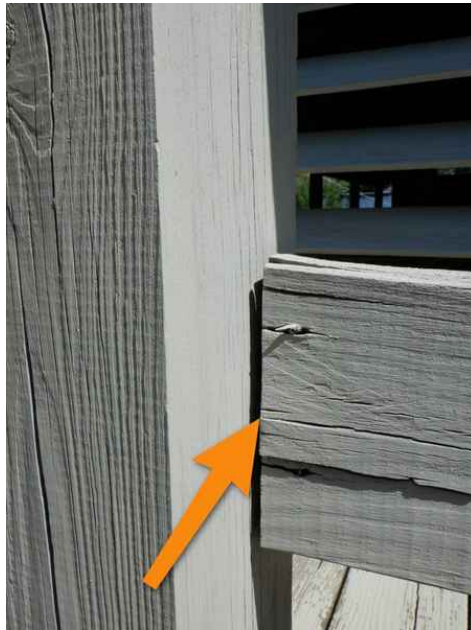
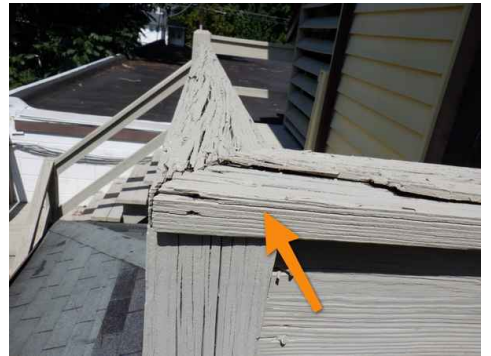
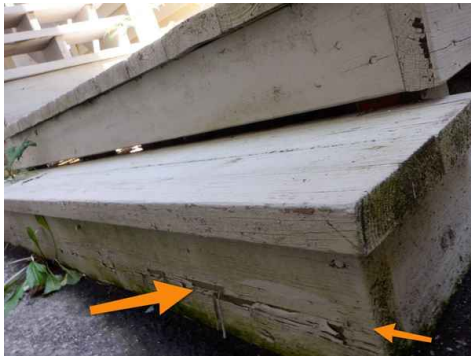
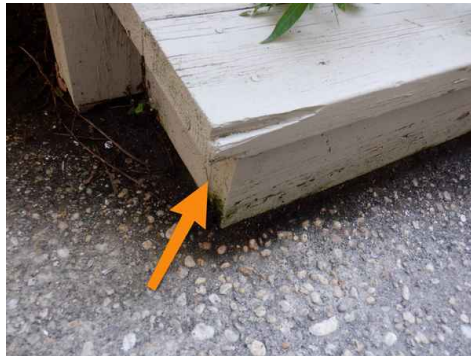
4.1.1 Decks, Balconies, Porches & Steps

Center stair horse is cracked and in need of replacement.

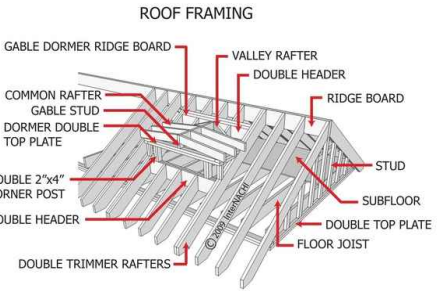
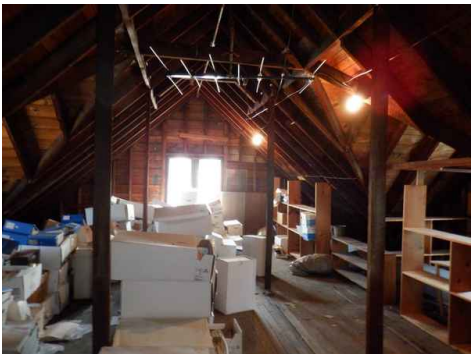
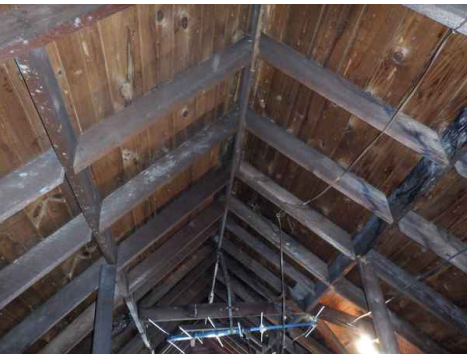
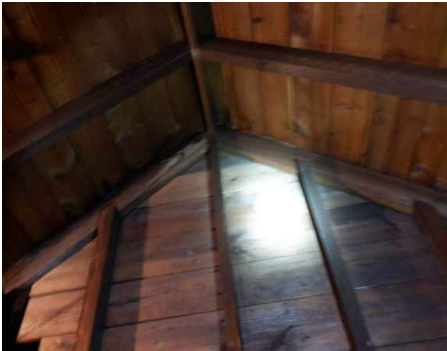
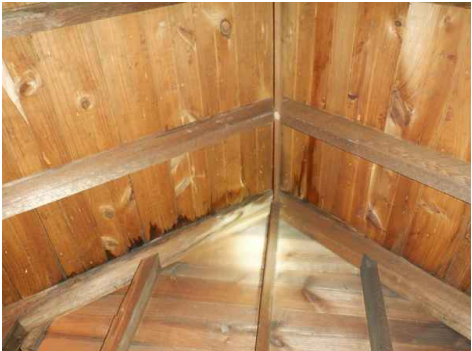
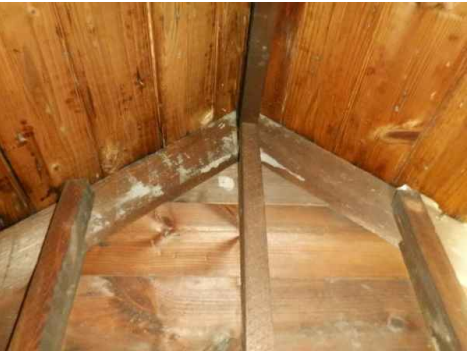
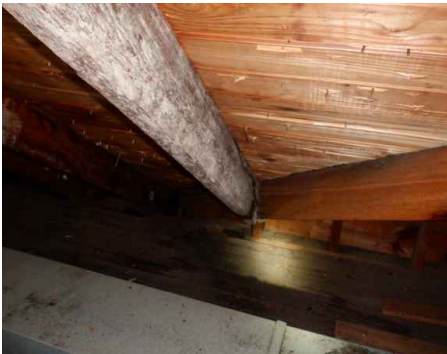
Insulation depth was inadequate. Recommend a qualified attic insulation contractor install additional insulation.

Attic venting was insufficient at time of inspection. Modern standards recommend 1.5 square feet of venting area for every 300 square feet of attic floor space. Recommend an attic contractor evaluate and remedy.

I observed a roof rafter that was cut to make room for a plumbing stack. I recommend it be repaired to prevent any roof sag in that area.

Recommendation
Contact a qualified insulation contractor.

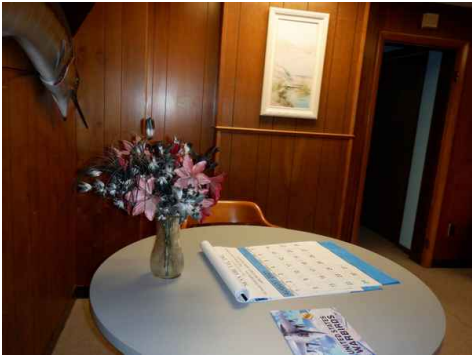
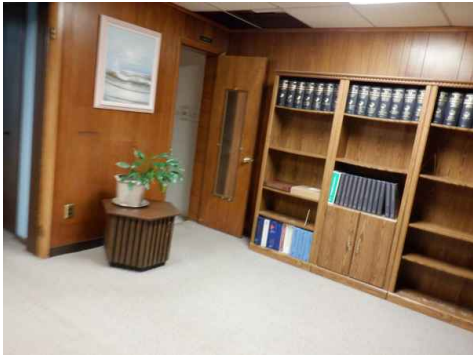
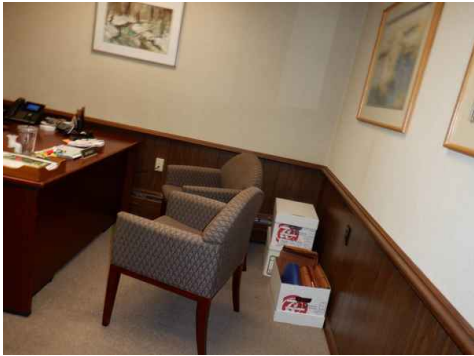
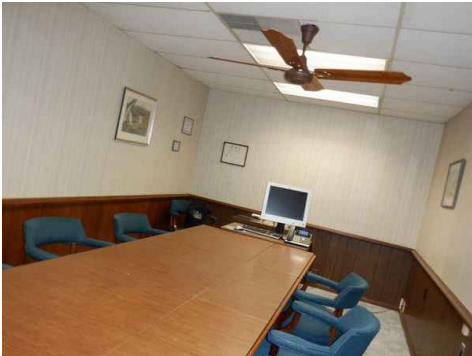
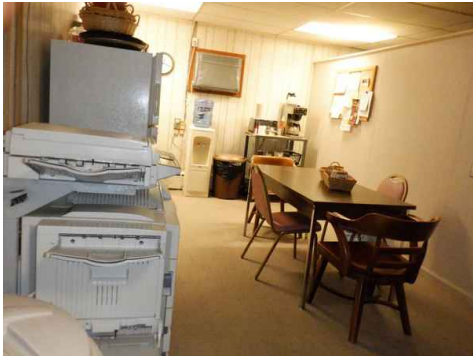
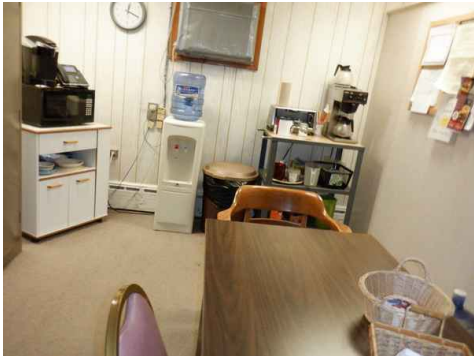
6.2.1 Floors

The floor showed uneven or sloped surfaces in some areas. This may be due to improper installation or previous settlement. This is common in older structures. Recommend a qualified contractor investigate floor structure, evaluate, and repair as needed.

Recommendation
Contact a qualified professional.

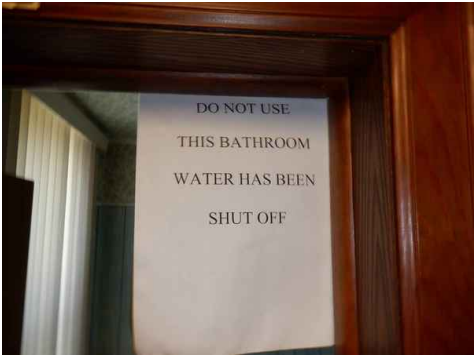
SECOND FLOOR BATHROOM

The water was turned off at the time of inspection. Recommend a licensed plumber evaluate the entire plumbing system prior to use.

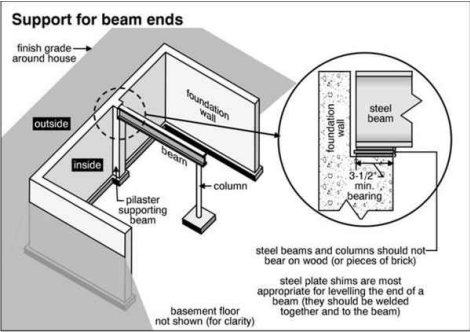
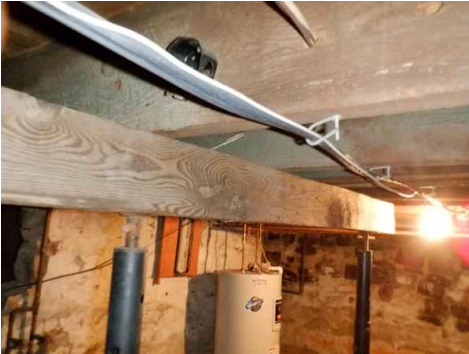
Temporary columns have been employed. Recommend a qualified contractor evaluate and install permanent column supports as needed.

Contact a qualified general contractor.

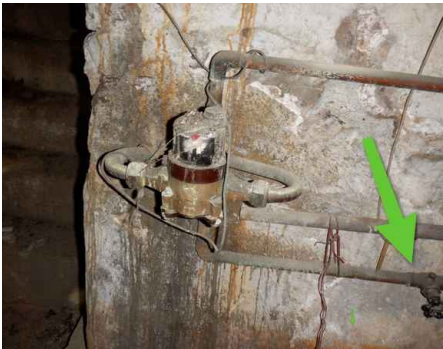
Main water shutoff valve

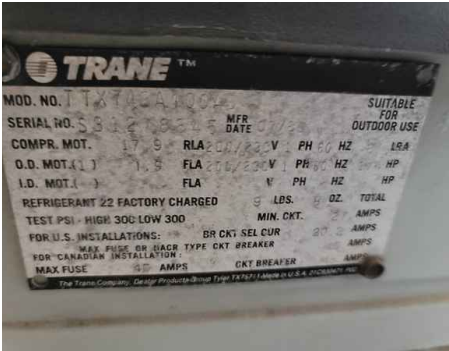
Manufactured in 1986

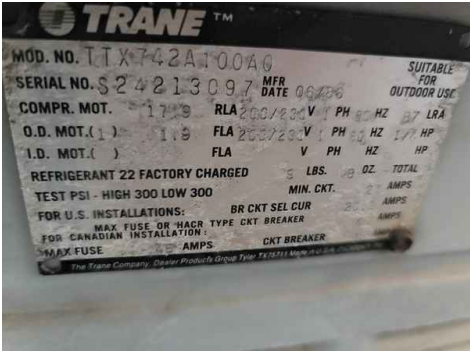
Manufactured in 1986

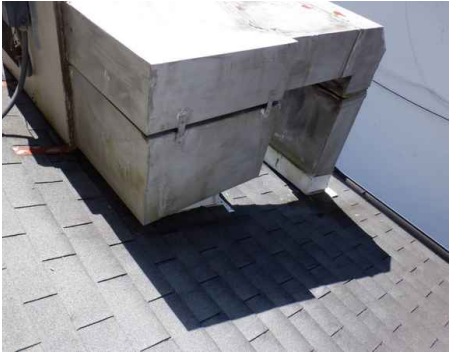
Unit for the side addition

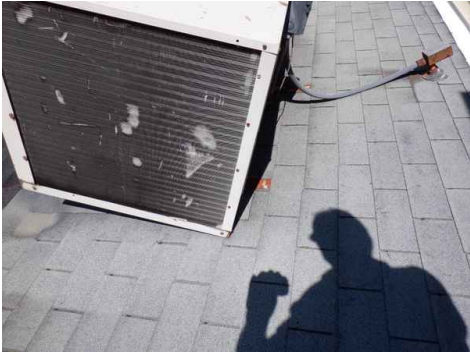
Unit for the side addition

I observed that the small package unit for the side addition was leaking condensate out of the cabinet instead of the drain. I recommend service by a qualified HVAC contractor.

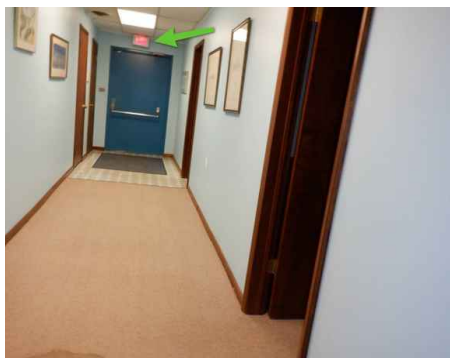
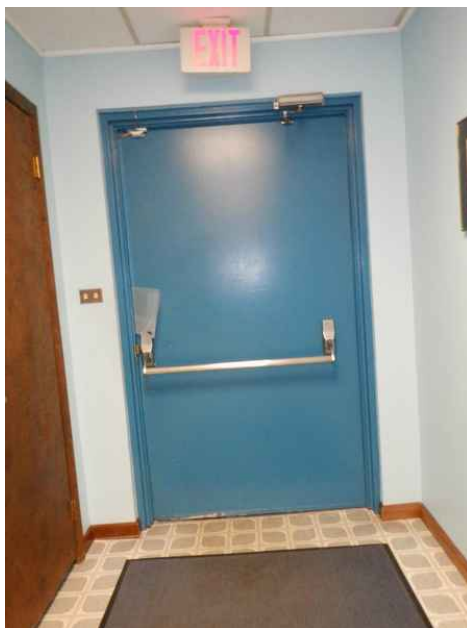
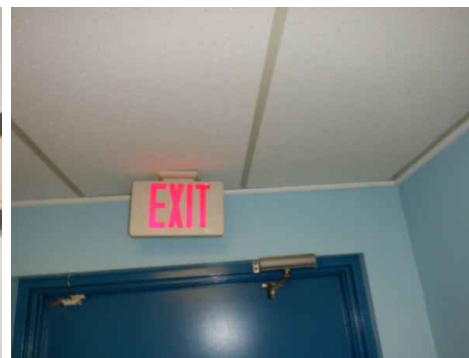
Entry & Exit: Satisfactory Condition

The egress areas appeared to be in overall satisfactory condition with little or no deficiencies.

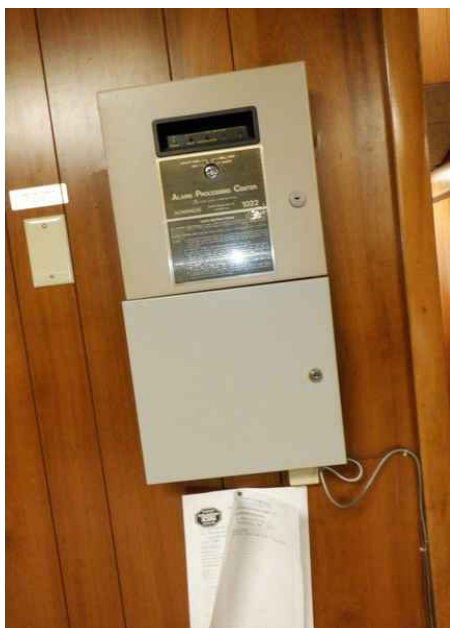
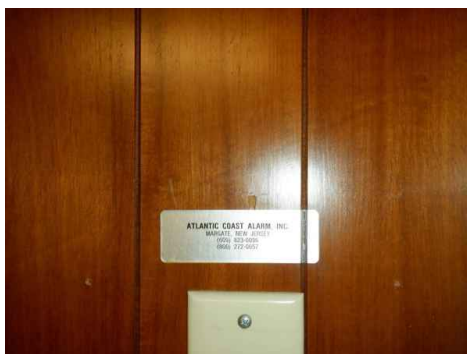
Fire Safety & CO: Placed Throughout

The components appeared to be installed and placed well throughout.

There is an alarm system installed and monitored by Atlantic Coast Alarm Co.
