ANDREWS PROPERTY INSPECTIONS LLC

COMMERCIAL PROPERTY INSPECTION

1234 Main St. Mays Landing NJ 08330

02/02/2022 9:00AM

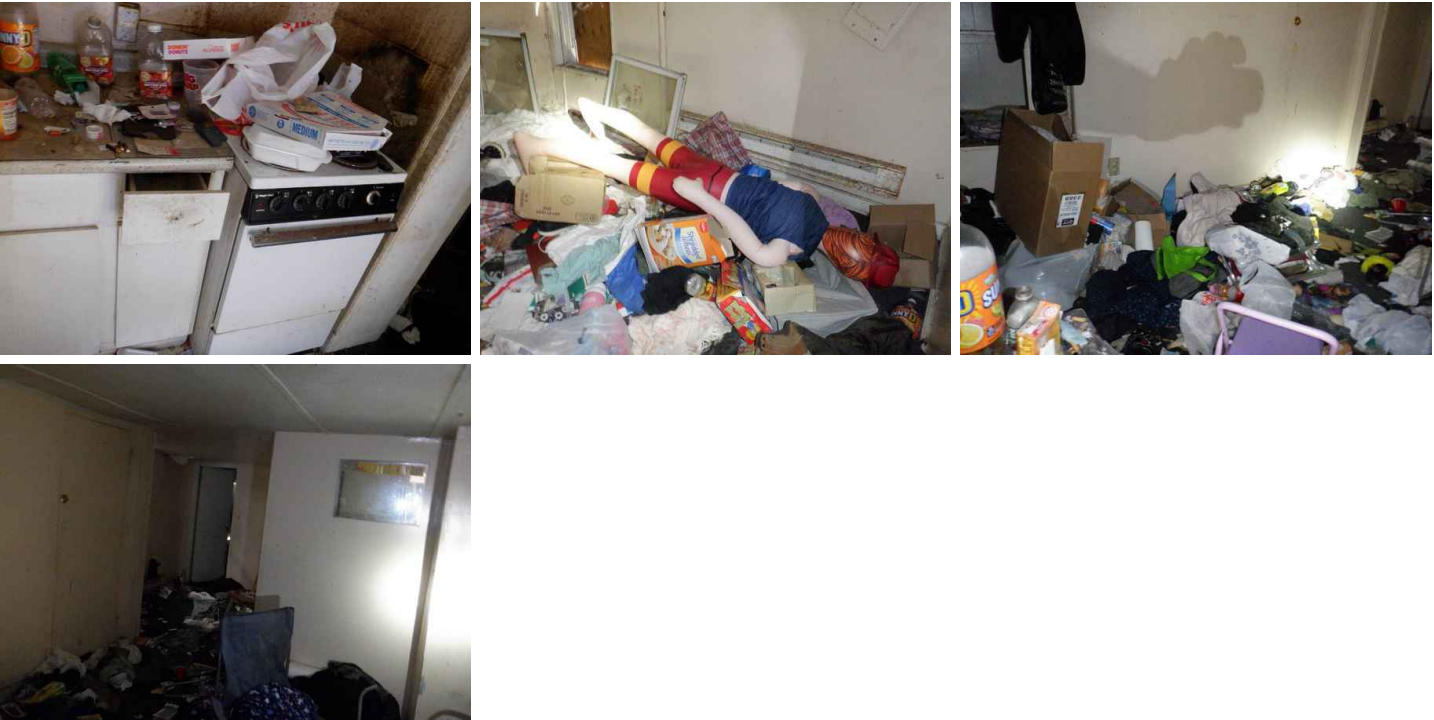
CLUTTERED AREAS

Some areas were covered with storage or clutter limiting the inspection.

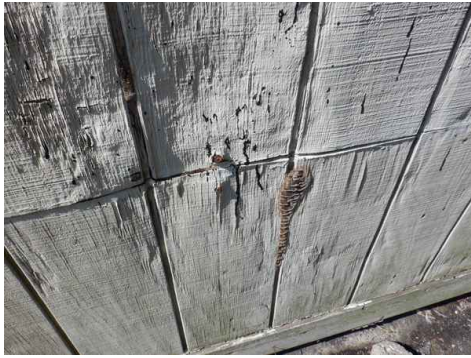
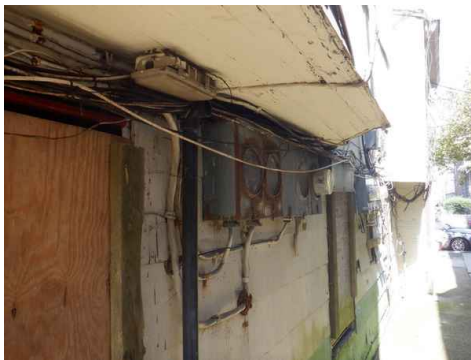
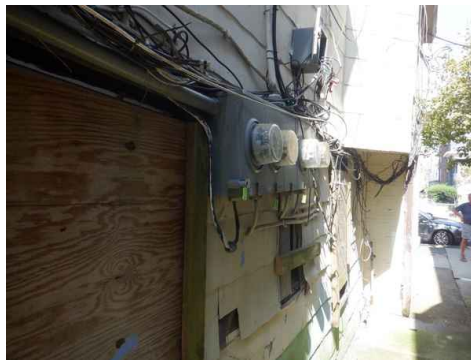
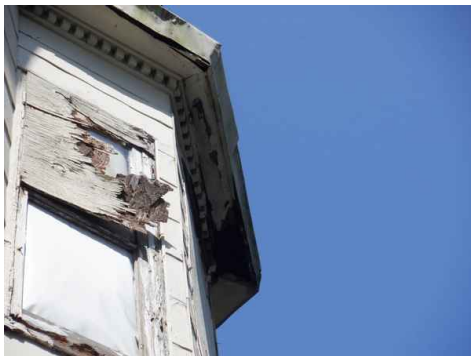
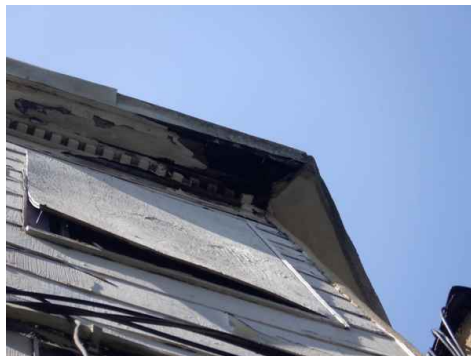
I pushed my thumb through the siding at the rear east corner, all the T-111 is like a sponge and very soft.

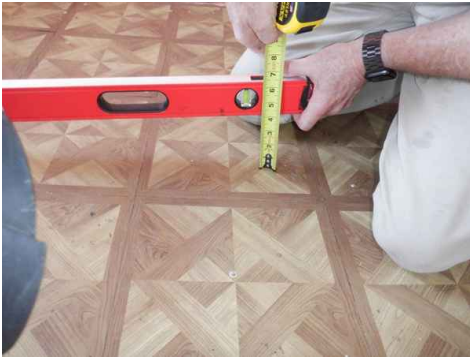
Measuring on the second floor front room

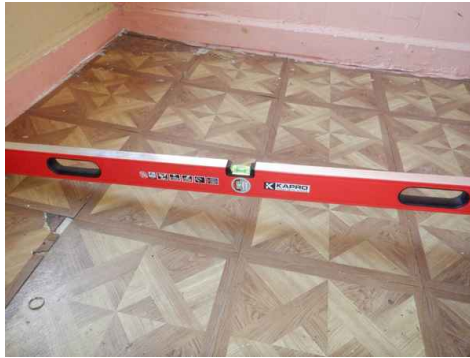
Measuring on the second floor front room
