ANDREWS PROPERTY INSPECTIONS LLC

ANDREWS COMMERCIAL INSPECTION REPORT

1234 Main Street
Mays Landing, NJ 08330

11/12/2023 9:00AM

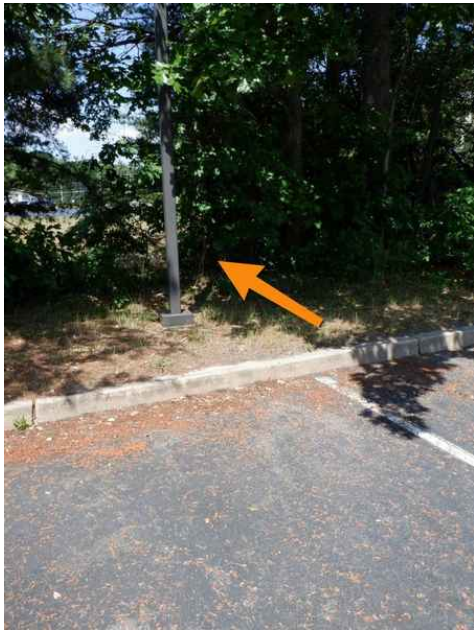
EXTERIOR LIGHT AND POLE MISSING.

he light on the right side of the parking lot

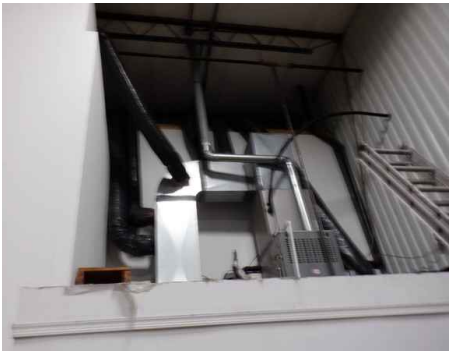
Office Heating System

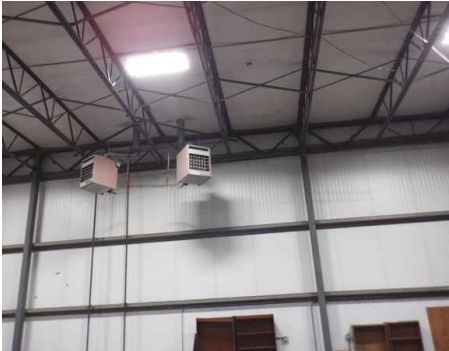
Reznor hanging gas fired heaters on the east side of the warehouse

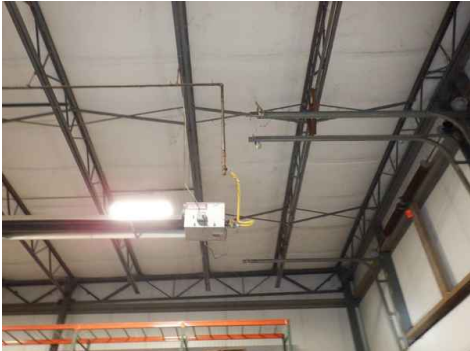
Reznor gas fired tube type radiant heater on the west side of the warehouse.

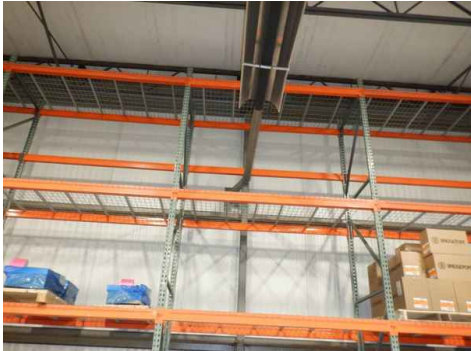
More of the Reznor tube heater

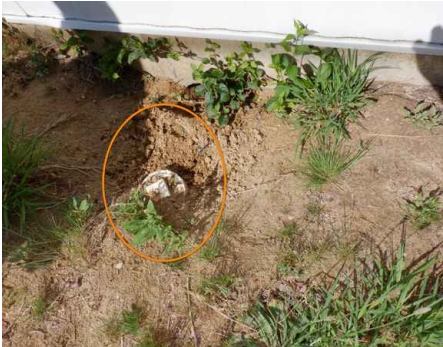
Left (East) side of the building

Sewer line clean out located here.

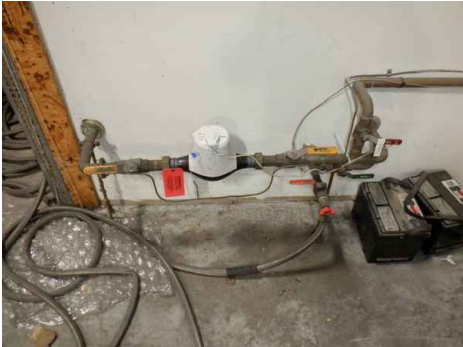
Next to the warehouse bathroom

Building's main water shutoff valve and water meter.

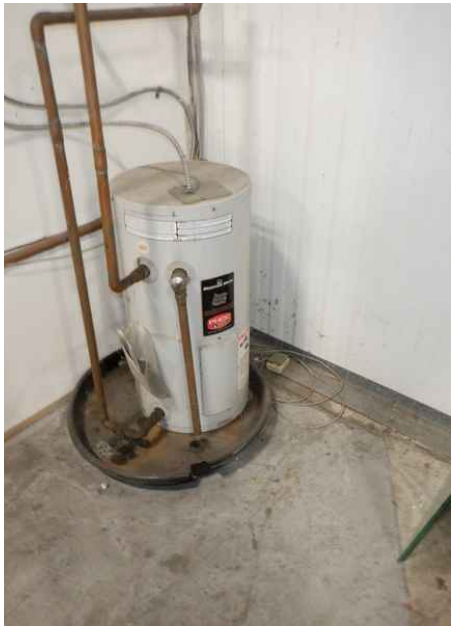
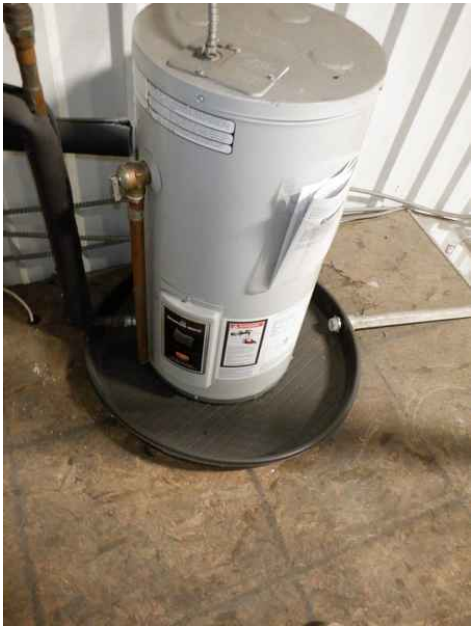
Hot Water Systems, Controls, Flues & Vents: Water Heater

There are 2 water heaters, one next to the warehouse bathroom and the other is up next to the office furnace.

I recommend flushing & servicing your water heater tank annually for optimal performance. Water temperature should be set to at least 120 degrees F to kill microbes and no higher than 130 degrees F to prevent scalding.

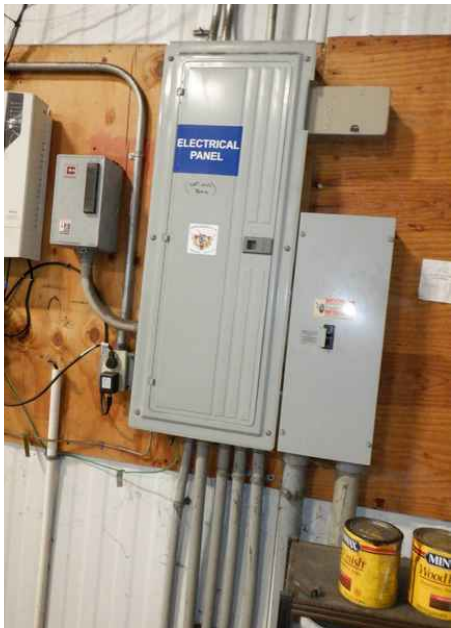
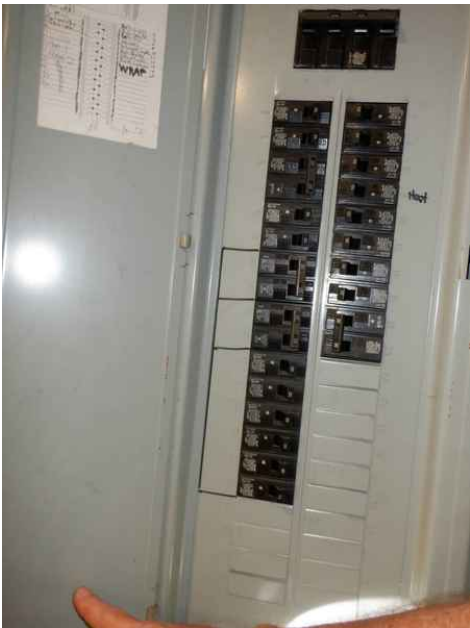
Main Panel: Panel Type
Circuit Breaker

Warehouse panel 120/240 volt 1 phase

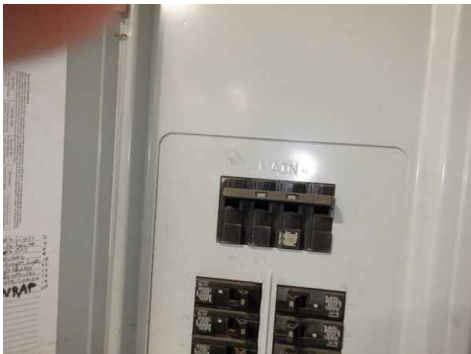
200 amp main for the warehouse section

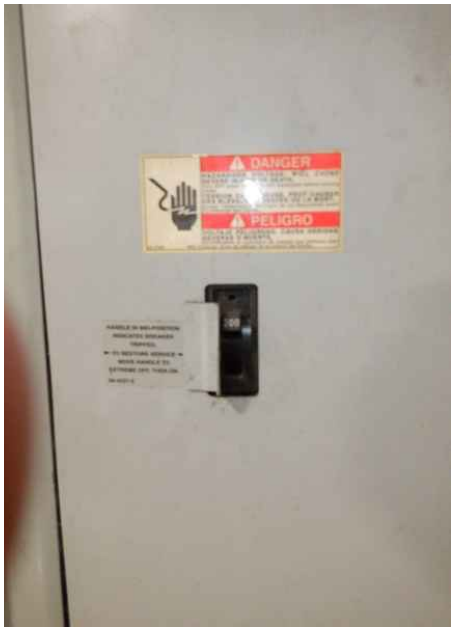
Main breaker feeding the office area panel.

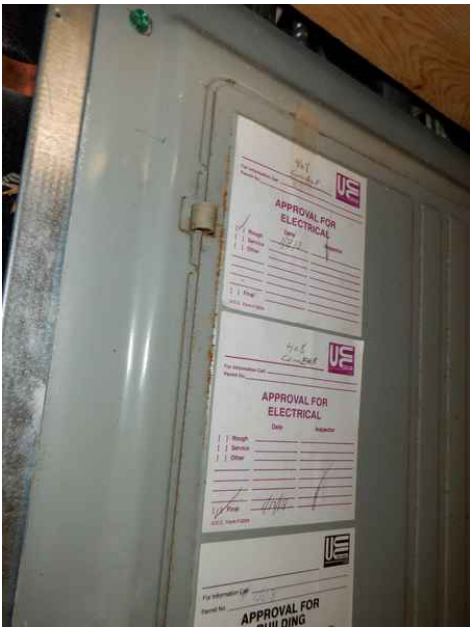
Inspection stickers for the office upgrade from 2013

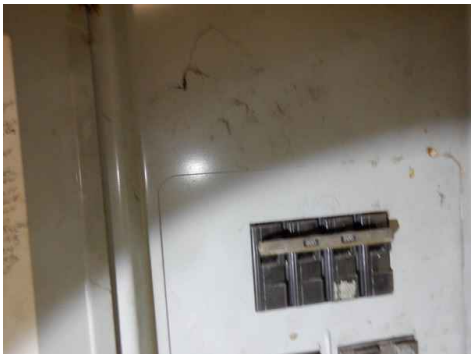
200 amp main for the office area

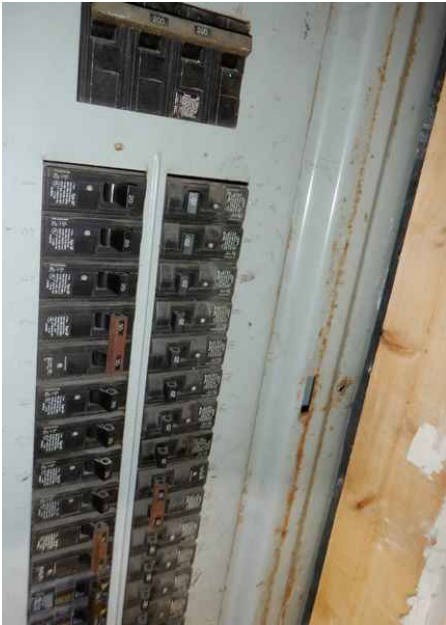
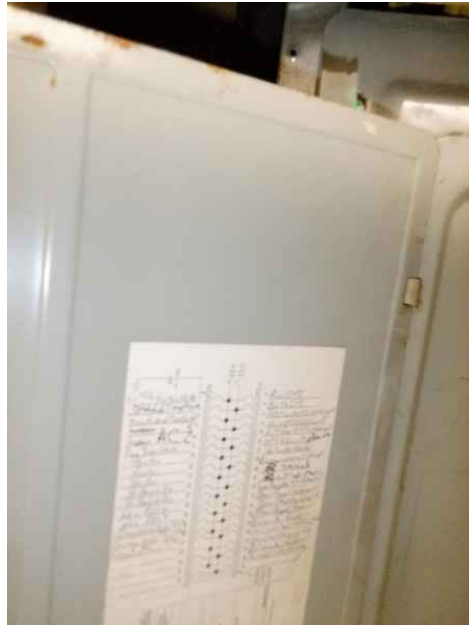
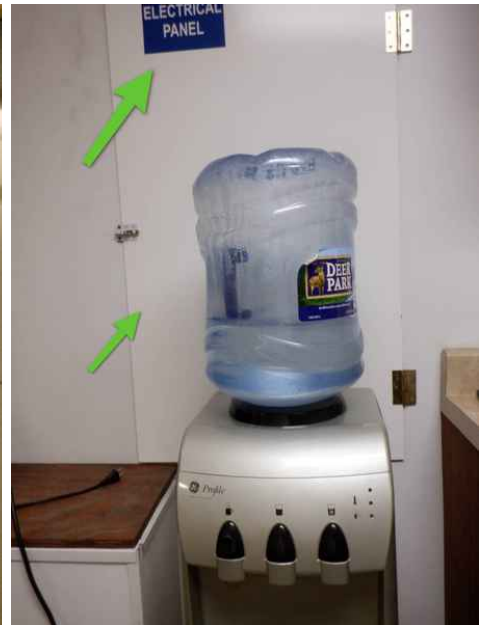
Office electric panel is behind this door

INADEQUATE CLEARANCE

A 3 foot by 3 foot square of clear space is required by most municipalities/countys recommend repair.

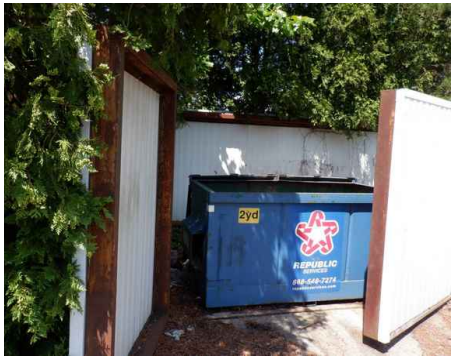
Dumpster Enclosure is in need of cleaning.
